Final Report FDOT Project BD521-02

# Performance Assessment of Portland Cement Pervious Pavement

## Report 4 of 4: Performance Assessment of a Pervious Concrete Pavement Used as a Shoulder for an Interstate Rest Area Parking Lot

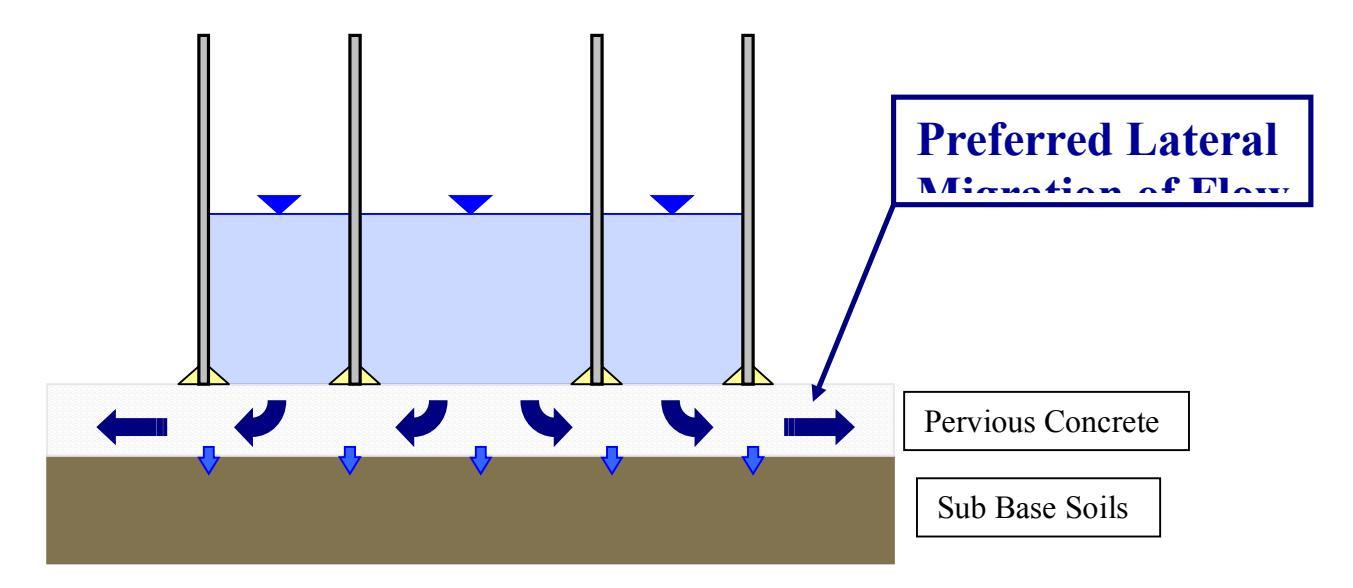
**Figure 1 - Double Ring Test on Pervious Concrete**

Prior to creation of a field infiltrometer, it was necessary to assess the operation of a standard infiltrometer. Initial testing was done using a standard double-ring infiltrometer (ASTM D3385-94) on the surface of the concrete similar to the procedure used by Bean and others in 2004. It quickly became apparent that this was an ineffective approach for pervious concrete because of the drastic difference in permeability between the concrete and the underlying soil (initial testing was done on newly poured pervious concrete). Once the infiltrating water moved through the pervious concrete and reached the soil it began to move laterally – See Figure 1. This grossly exaggerated the infiltration rate for the pervious system because it did not take into account the fact that water simply filled up the free pore space adjacent to the double ring infiltrometer and water was not infiltrating into the subsoil nearly as quickly as it appeared.

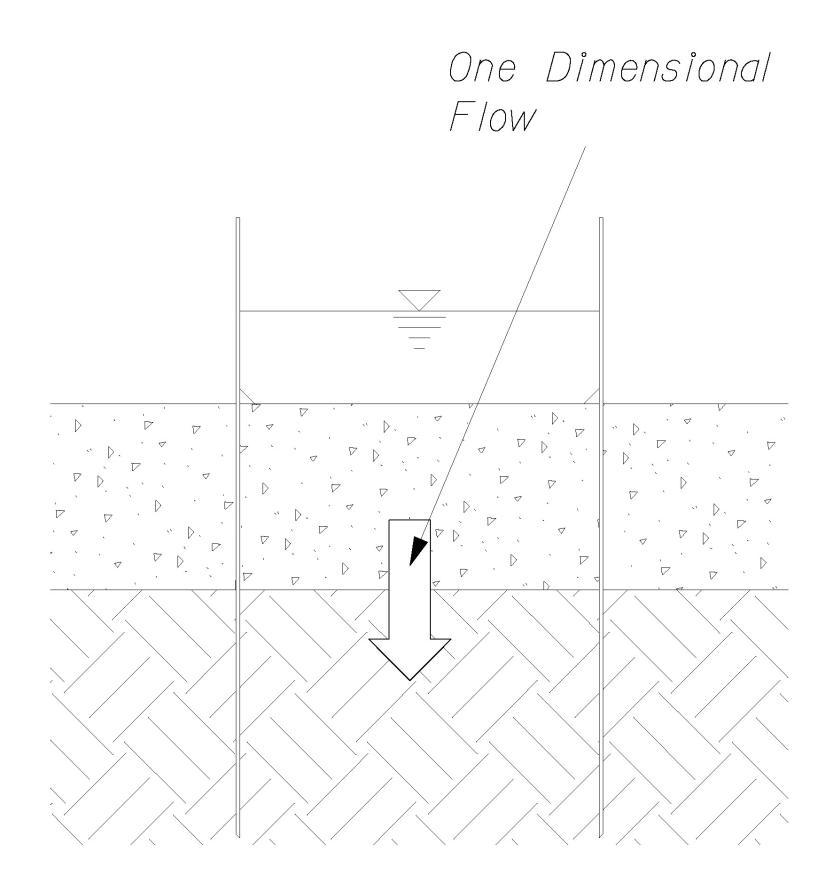
### Figure 2 - One Dimensional Flow at Soil-Concrete Interface

After several of these tests with double-rings on the surface of the concrete, it was decided that it was necessary to treat the pervious concrete – soil interface as a "system". It was only when the two layers were isolated and one-dimensional flow encouraged, that a more realistic measurement of performance was obtained (See Figure 2).

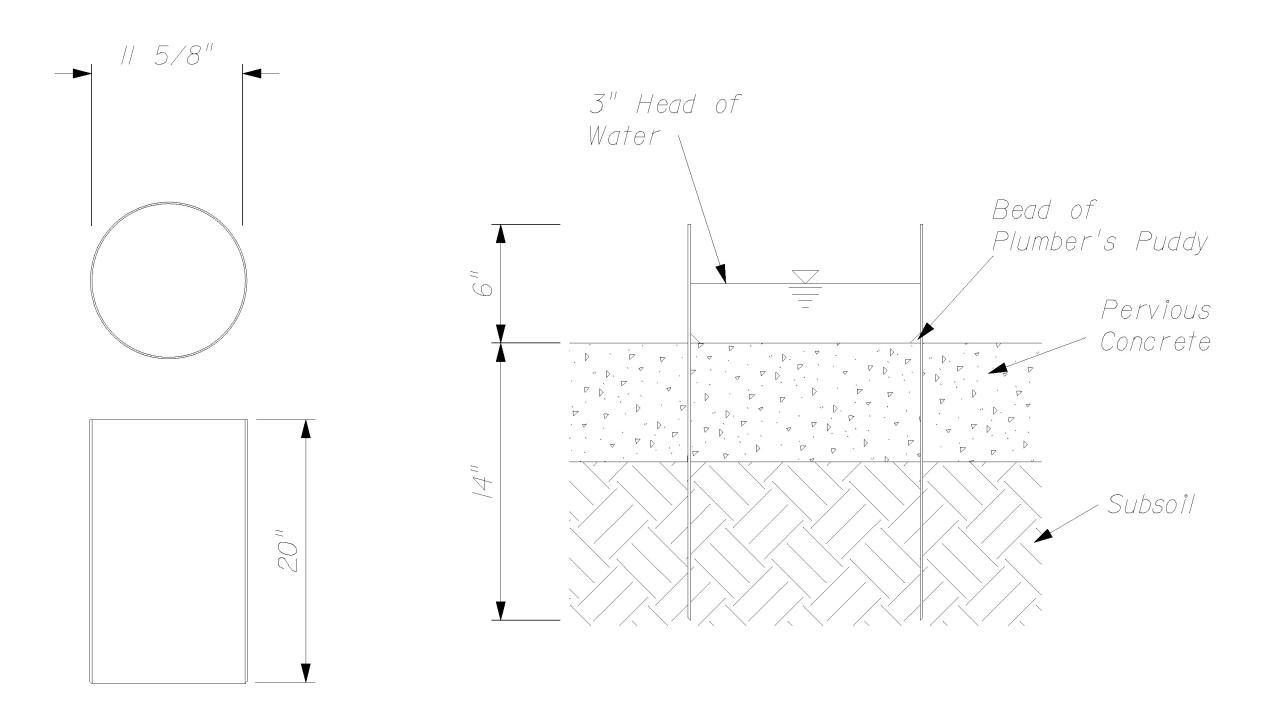
Figure 3 - Single-Ring Infiltrometer for Use with Existing Pavements

For existing pavements, it was decided that a way to approach this was to remove a circular section of concrete using a concrete coring machine (Wanielista, et.al., Jan 2007). A 12-inch diameter core bit was used because it was large enough to provide a "representative area" and small enough to be easily handled. A tube was designed to be inserted around the concrete core and embedded into the underlying soil – a single-ring infiltrometer which

encourages one-dimensional flow through the interface of the pervious concrete and the soil. Figure 3 shows the dimensions for a single-ring infiltrometer used for existing paving.

The testing procedure for the single-ring infiltrometer was much like that for the doublering test – a specific head was maintained, water was added at specified time intervals, and the amount of water added at each time interval was recorded. The tests were stopped after at least two consecutive time periods after which approximately equal additions of water were added, provided that at least one inch of water over the area was added. One inch is equivalent to the 90% occurrence storm.

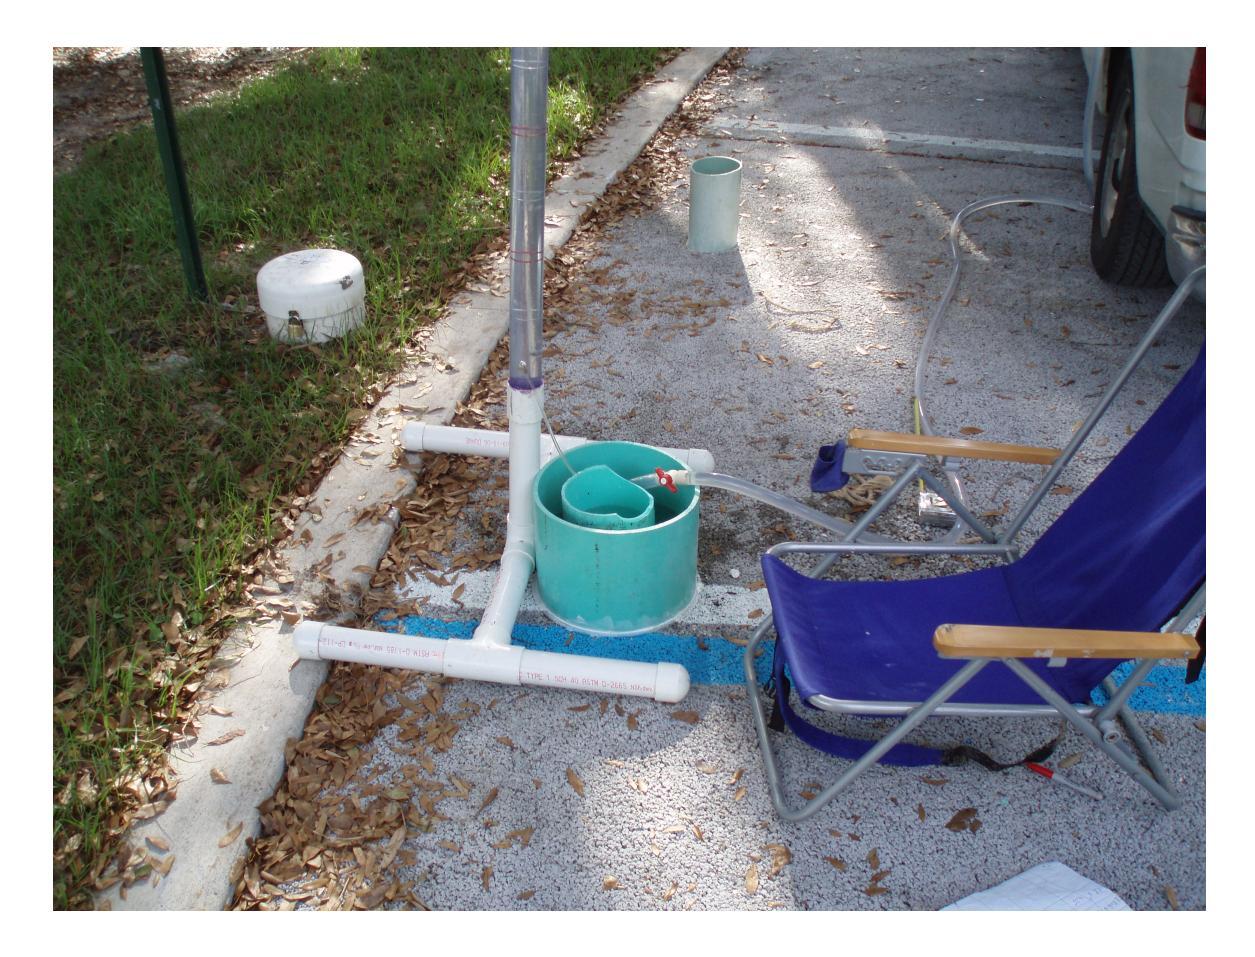
## Figure 4 - Embedded Ring Infiltrometer Kit Showing On-Site Measurement

The ERIK consists of inner embedded 6 inch diameter pipe, an outer embedded 12 inch diameter pipe, a 2 inch ID graduated "reservoir" cylinder with red marks indicating every inch drop in water level within the embedded ring, and a timing device with a recording pad. The complete set up is shown in Figure 4. On the present model, there are two manually adjusting valves located near the bottom to control flow of water out of the reservoir cylinder. A 6 inch and 12 inch ID PVC pipe are included for the embedment and testing applications. (Note: The 9 inch drop in the reservoir pipe will equal a 1 inch drop in the 6 inch inner testing infiltrometer pipe)

- 1. Place the inner (six (6) inch pipe) and the outer (nine (9) inch pipe) on the top of the embedded pipes.
- 2. Apply bead of silicone caulking around bottom of 6 inch and 9 inch test pipes.
- 3. Allow time for drying or about 15 minutes with the silicone used.
- 4. Fill rings with water until saturation is reached and check for side leakage
- 5. Using tape measure, pour water until desired head is reached and mark inside wall of the inner pipe with permanent marker
- 6. Adjust valves on reservoir to keep a constant head desired in the inner pipe
- 7. Record time it takes for water level to drop to each marked interval

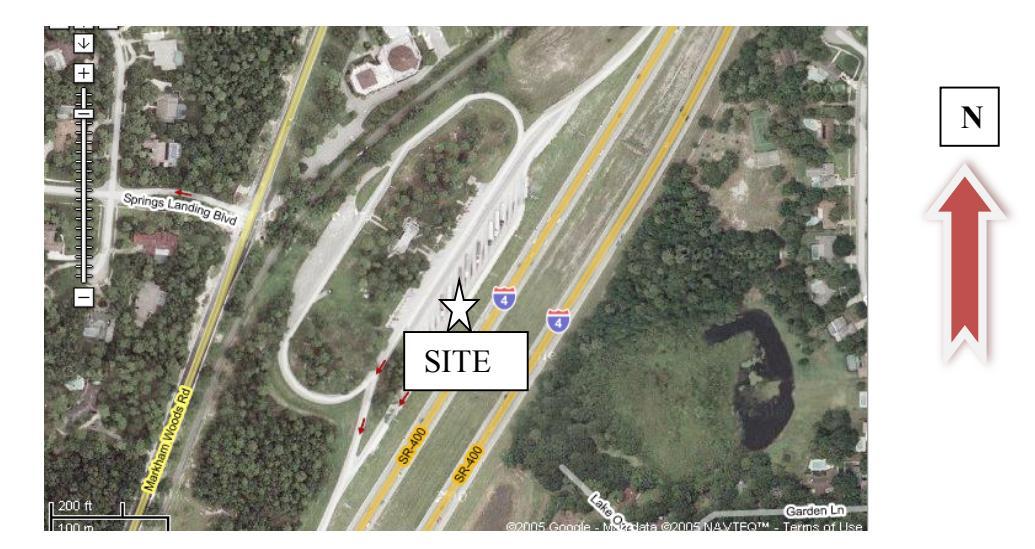
Figure 5 - Site Map for Pervious Concrete Shoulder

An interstate rest area was selected because the watershed had a length of flow equal to 100 feet and the slope (about 5%) was toward the shoulder area. The shoulder area was constructed at a standard width of 10 feet and was 90 feet long. The area is along Interstate 4 in central Florida (Figure 5). Also, there was on site evidence that the runoff water was eroding the loose shoulder materials and traffic was using the shoulder area for parking.

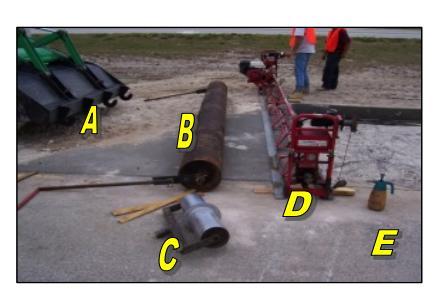
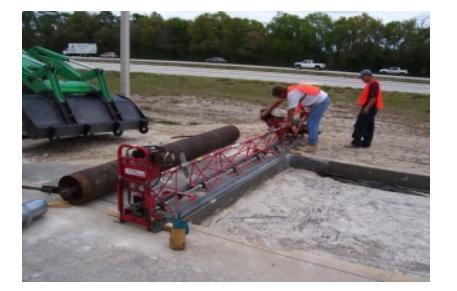
#### **Figure 6 - Pervious Concrete Equipment Used**

- A. BACK HOE (lifting)
- B. STEEL ROLLER (compaction)
- C. GROOVER (controlled expansion joints)
- D. VIBRATORY POWER SCREEDER (to "Strike-off" and remove excess concrete)
- E. LUBRICANT (keeps tools clean "a clean tool is a happy tool")

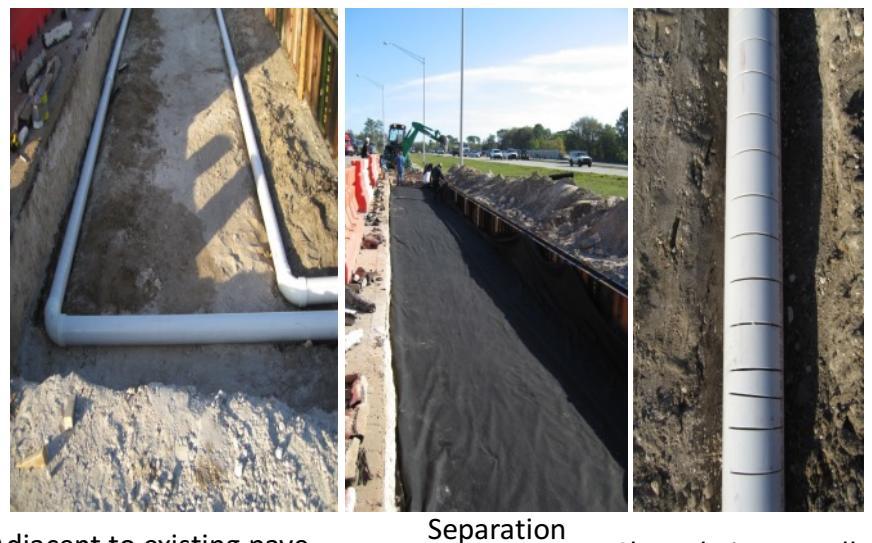
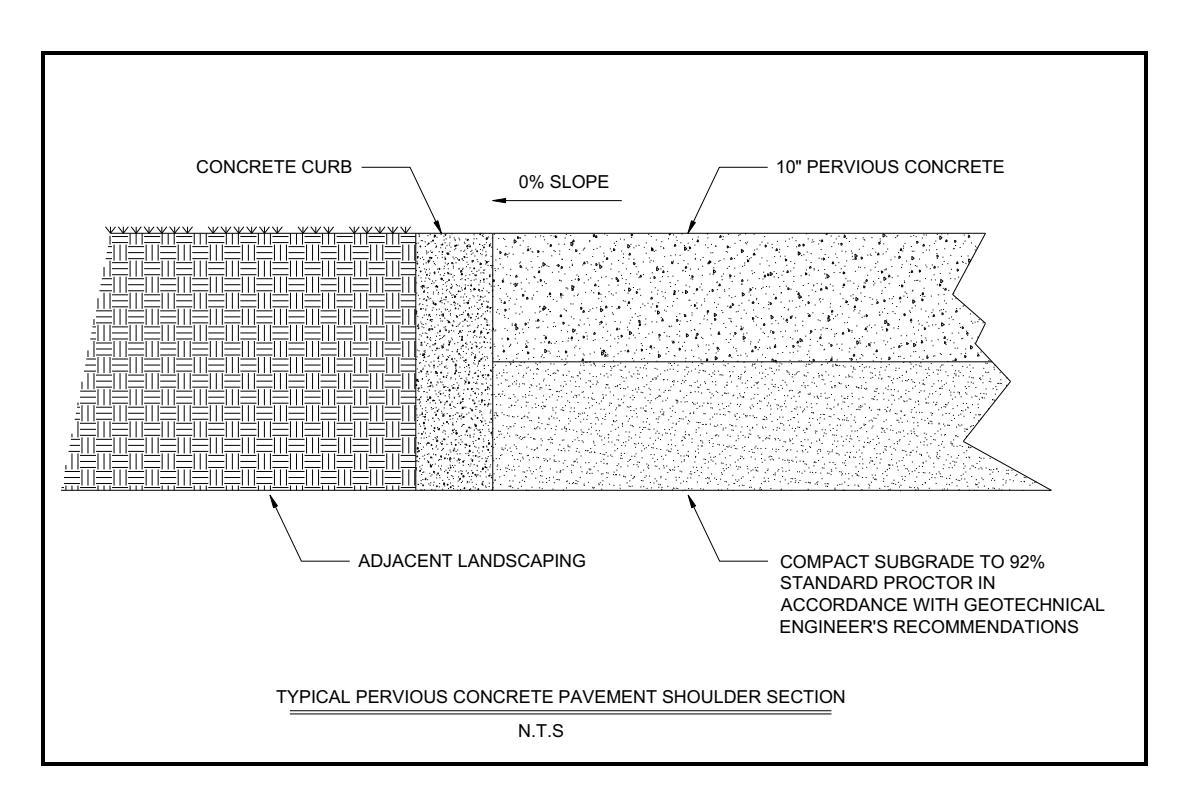
Figure 8 - Shoulder Pervious Concrete Section for I-4 Rest Area

Since the rest area parking does contribute runoff volume to the shoulder area, two collection slotted pipes were placed at the bottom of the reservoir (22 inches below grade) to document the runoff volume and to provide storage for water quality analyses (see Figure 7). A section is shown in Figure 8. The first pipe was located at the edge of the parking area, and the second one seven feet from the parking area edge. The volume of water collected from the edge pipe was at least fifty times greater than that collected from the pipe seven feet from the edge. There was no visible water collected at the edge of the pervious concrete shoulder for the rainfall conditions experience over the one year of measurement (June 2006 – June 2007). The rainfall in this time period was approximately 44 inches. The normal rainfall for the same period is approximately 49 inches. It is estimated that the pervious concrete has infiltrated almost all of the water that was transported to it and all of the rainfall on it.

Adjacent to existing pave And 7 feet from edge of pave

tion Slotted pipe to collect Infiltrated water

Fabric
