Performance of a Bio-Retention System In Stormwater Retention Areas

Martin Wanielista
University of Central Florida

South Florida Water Management District Seminar
West Palm Beach, Florida September 14, 2012

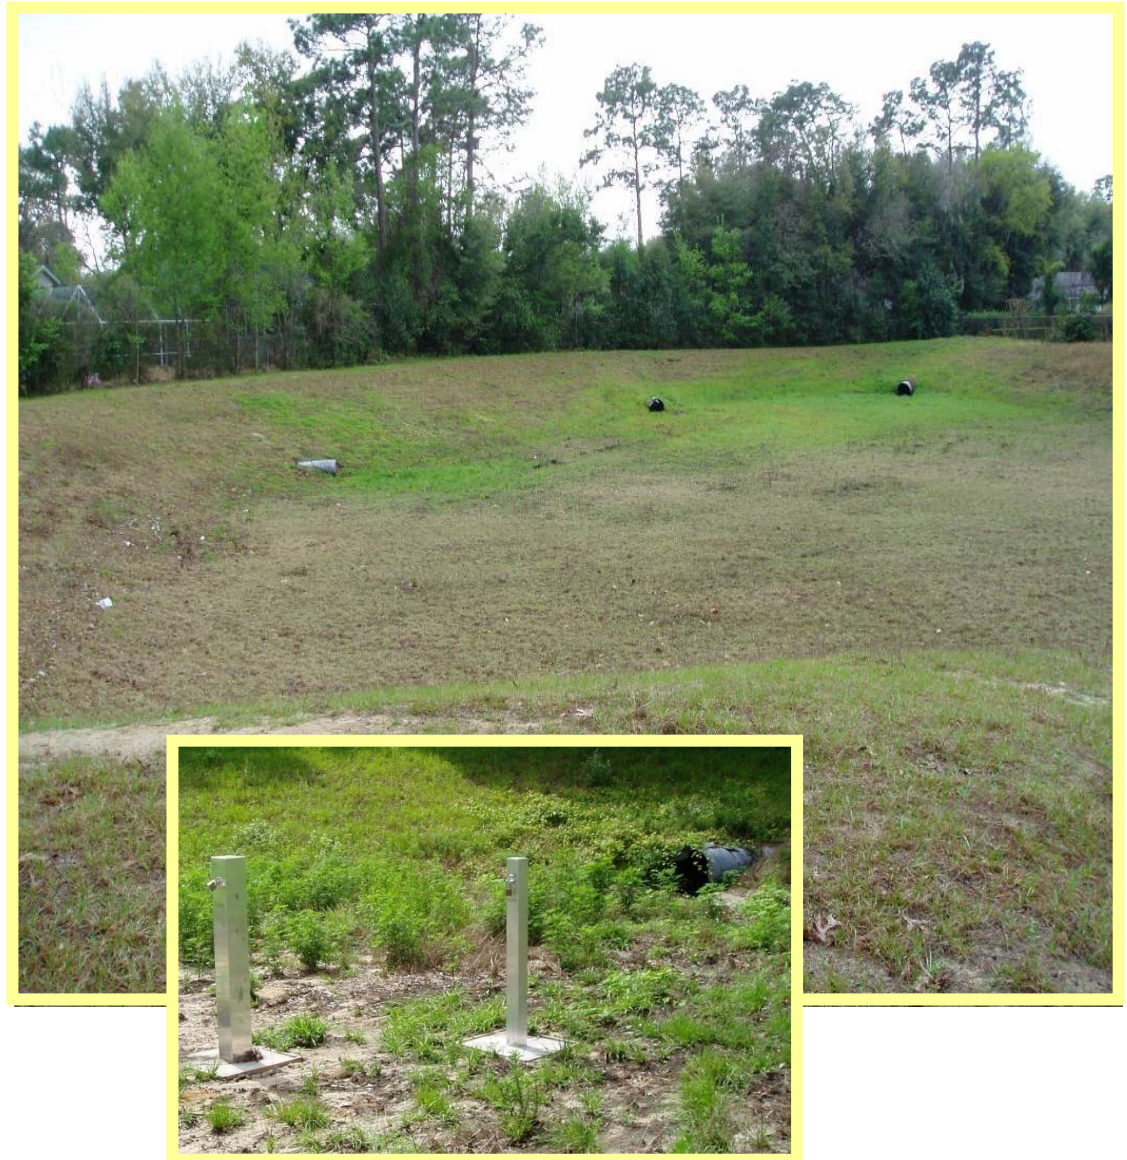
Hunters Trace (HT) Basin

- 0.7 ac basin,
- 10 ft deep, 51' bottom ~61-62' at the top
- 56 ac drainage basin, only 4.2 ac EIA
- Water table ~10 ft below basin bottom
 - Well sampling location

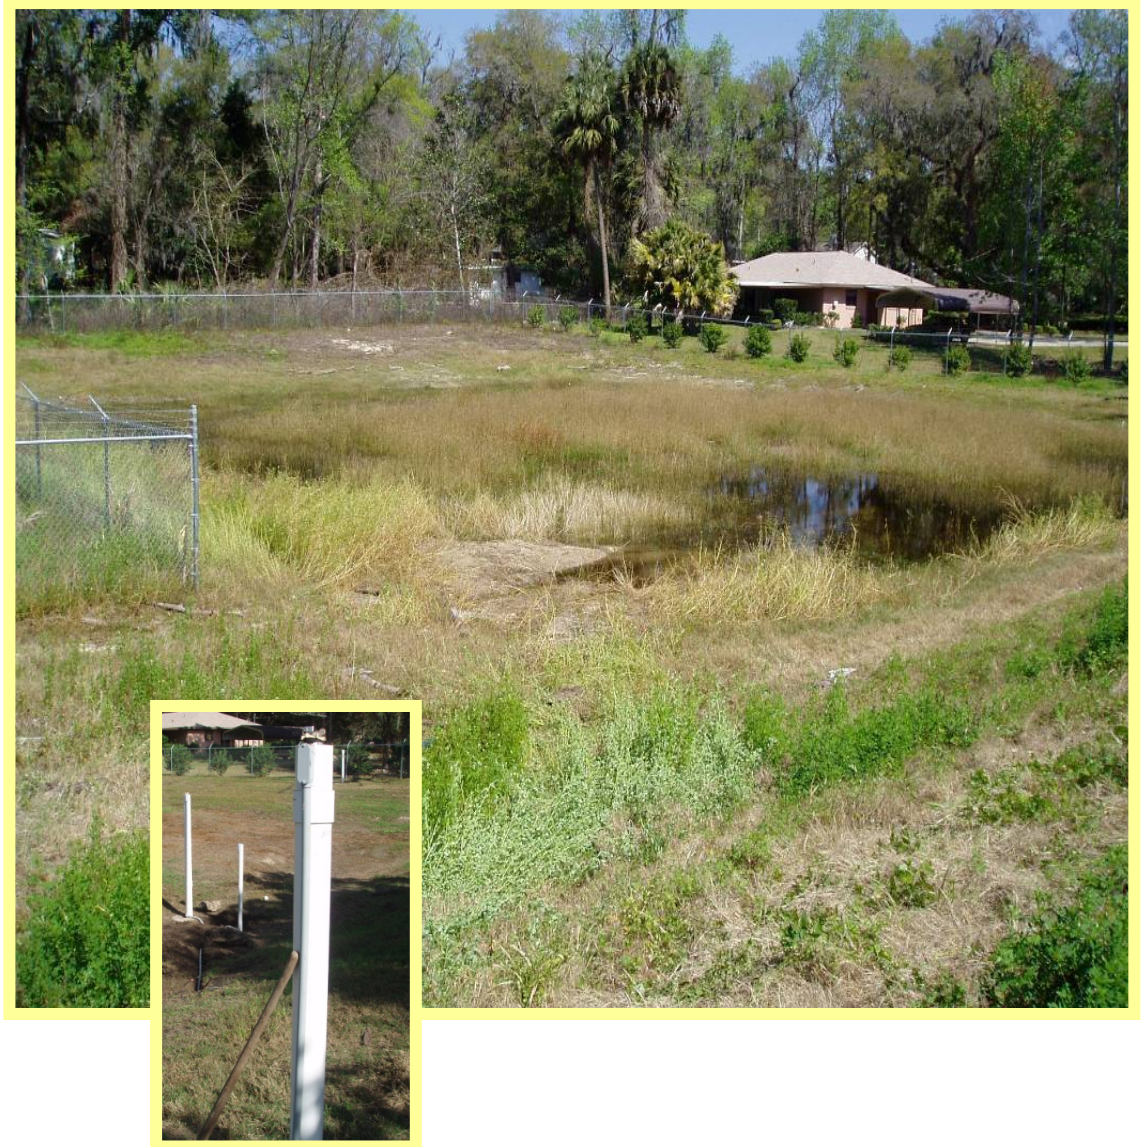
South Oak (SO) Basin

- 0.4 ac basin,
- 5 ft deep
- 72 ac drainage basin only ~ 3.6 ac EIA
- Water table normally at basin bottom
 - Well sampling location

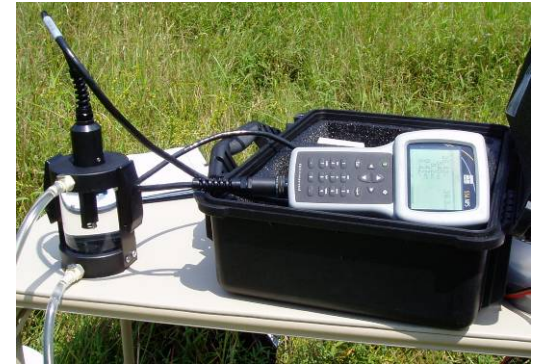
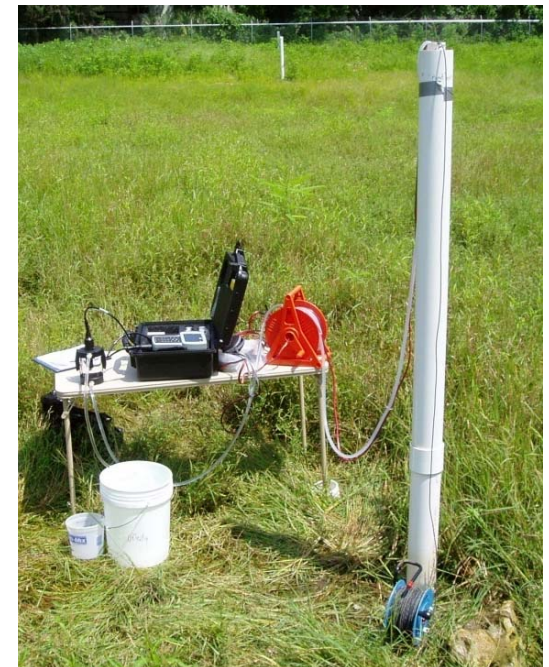
FIELD INSTRUMENTATION

- Ground-water level
- Basin water stage
- Rainfall

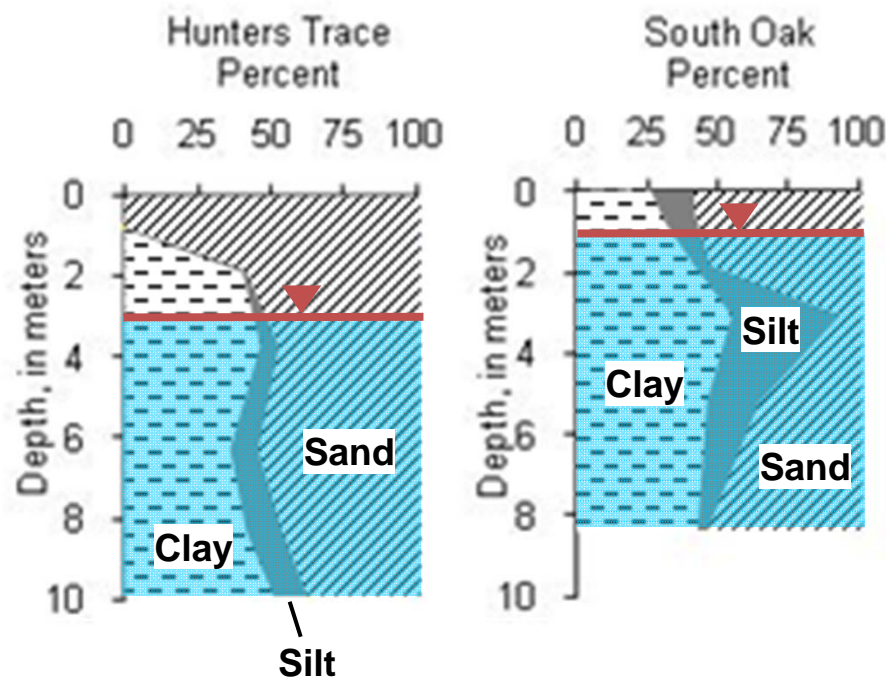
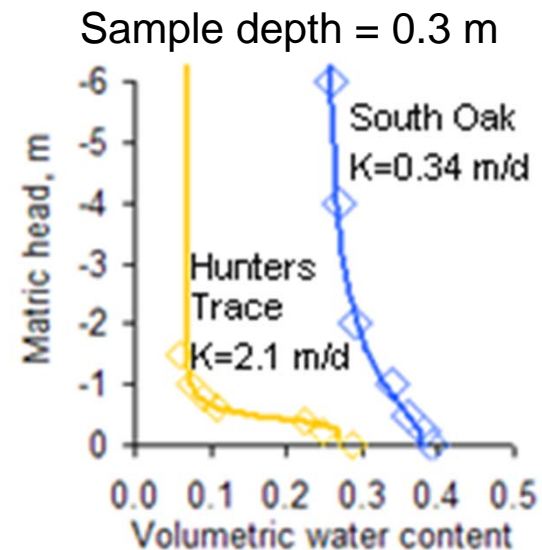
SOIL CHARACTERISTICS

- Textural differences contributed to large differences in the soil moisture retention curves.
- Soil moisture is important because O_2 diffusion through water is 10,000 times less than through air.

- South Oak soils
 - Uniformly graded
 - Classified Sand on textural triangle
 - 8.5-12.5% silt/clay (USDA)
- Hunter's Trace soils
 - Uniformly graded
 - Classified Sand on textural triangle
 - 1-3.2% silt/clay (USDA)

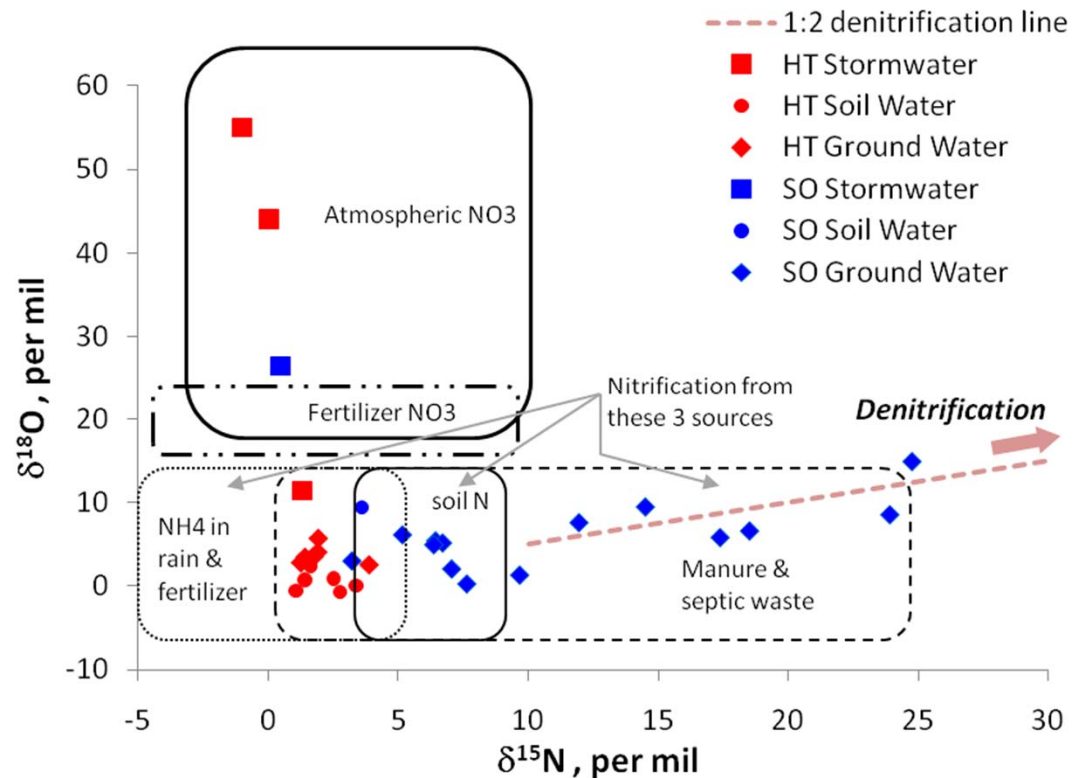
NITRATE TRANSPORT & FATE

At the SO basin, evidence of denitrification is supported by

- Excess N_2 concentrations as high as 3 mg/L; and
- Isotopically heavy ^{15}N and ^{18}O of nitrate (up to 25 and 15‰, respectively).

At the HT basin, no excess N_2 and no isotopic enrichment thus minimum denitrification.

Outlines of typical nitrate source ranges from Kendall and Aravena (2000)

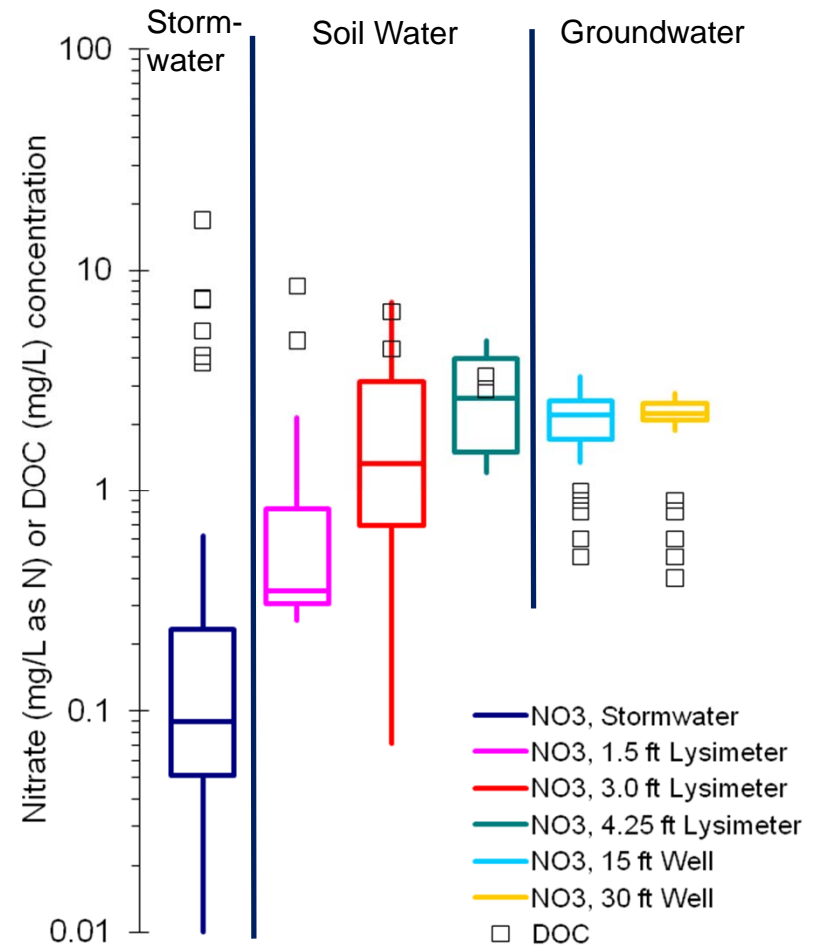
BIOGEOCHEMICAL PROCESSES

- Aerobic conditions (dissolved oxygen 5-8 mg/L) persisted beneath the HT basin, resulting in depletion of dissolved organic carbon (DOC) and NO_3^- leaching.
- Aerobic conditions precluded the reduction of other electron acceptors.

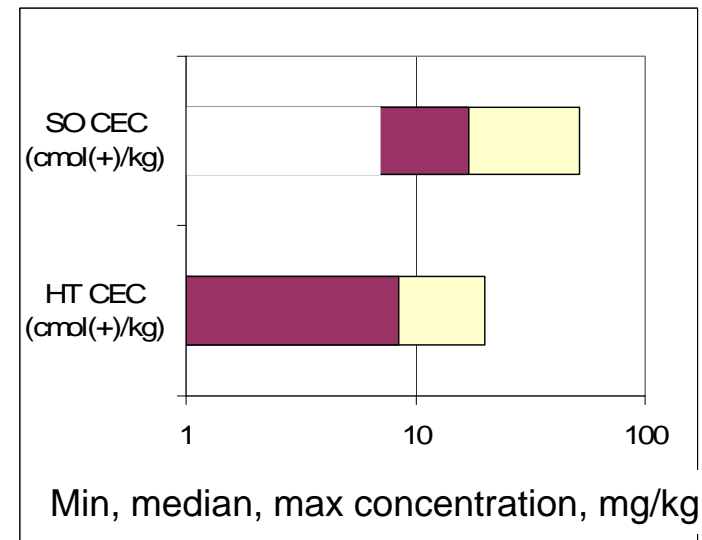
SOIL ANALYSIS – Chemistry

- CEC higher at South Oak
- Higher CEC than typical Florida soils, likely due to prevalence of clay mineral smectite

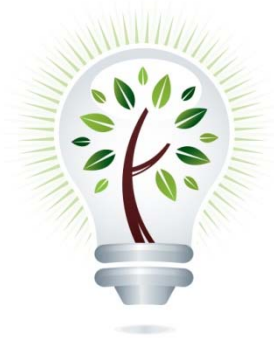
Soil Texture and Bio Chemical Properties

- Can we replicate the conditions at the SO basin at the HT basin?
 - Soil Moisture is the primary goal.
 - Reproduce the soil conditions found at SO at HT
 - Soil amendment that is economical.

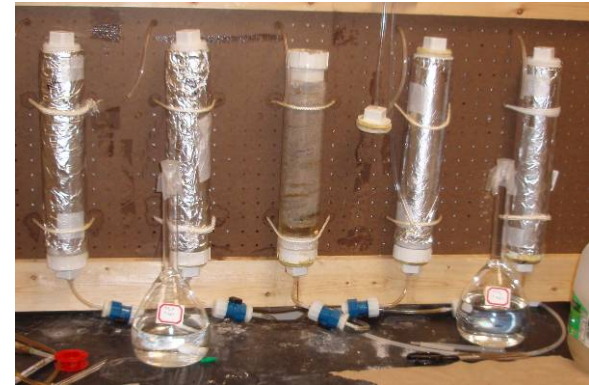
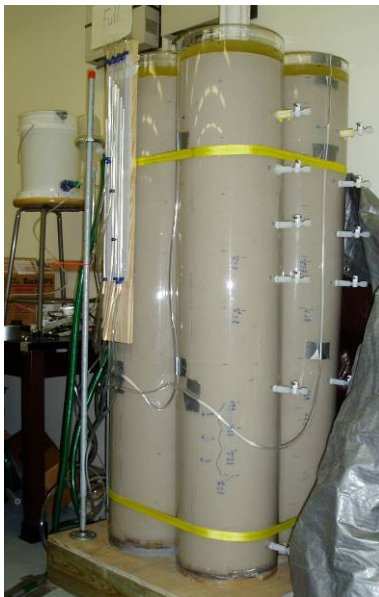
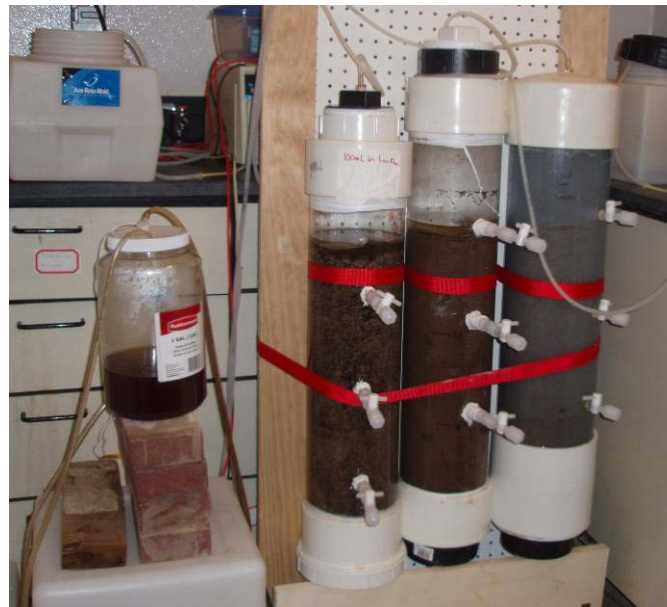
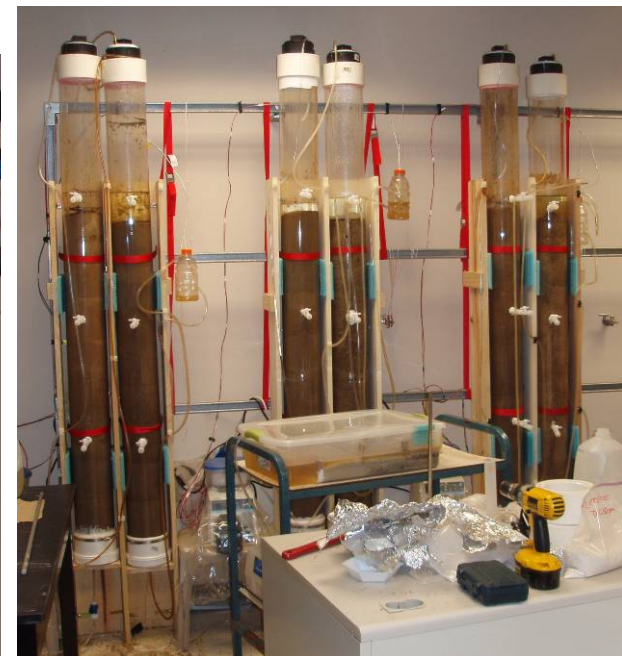
LABORATORY SOIL COLUMNS

- Test selected media mixtures to quantify their nutrient attenuation capabilities
- More closely resemble natural conditions than batch tests

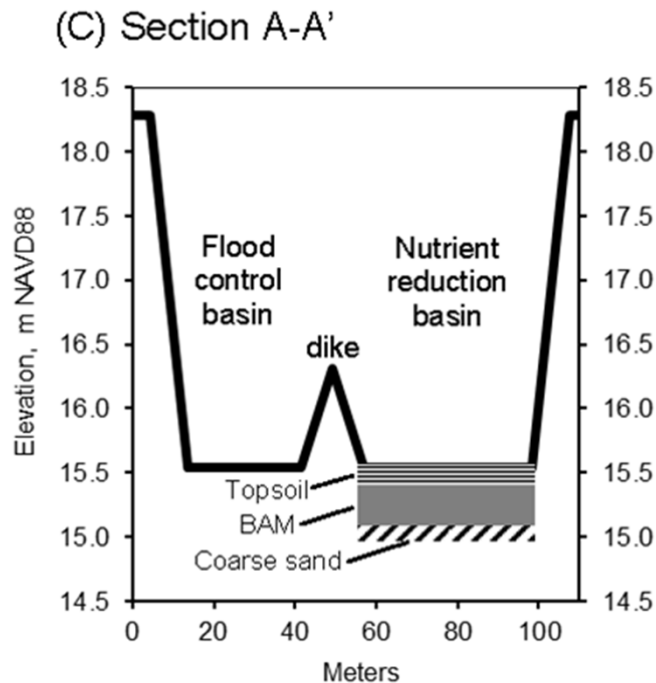
HUNTER'S TRACE – NEW BMP

1. Excavation of native soil in the bottom of a portion of the HT existing basin.
2. Re-placement of a 1 foot (0.3 m) thick amended BAM soil layer: 1.0:1.9:4.1 mixture (by volume) of tire crumb (for sorption capacity), to clayey sand (for soil moisture retention); and sand (for infiltration rate).
3. Construction of a berm forming separate pollution (nutrient) control and flood control basins.
4. Cost was \$6/SF of nutrient control area (not including permit and other related fees).

- Reproduce soil conditions that exist at the SO basin by using an amended soil layer (BAM):
 - Increase soil moisture thus
 - Reduce oxygen transport
 - Increase sorption capacity
 - encourage denitrifier growth

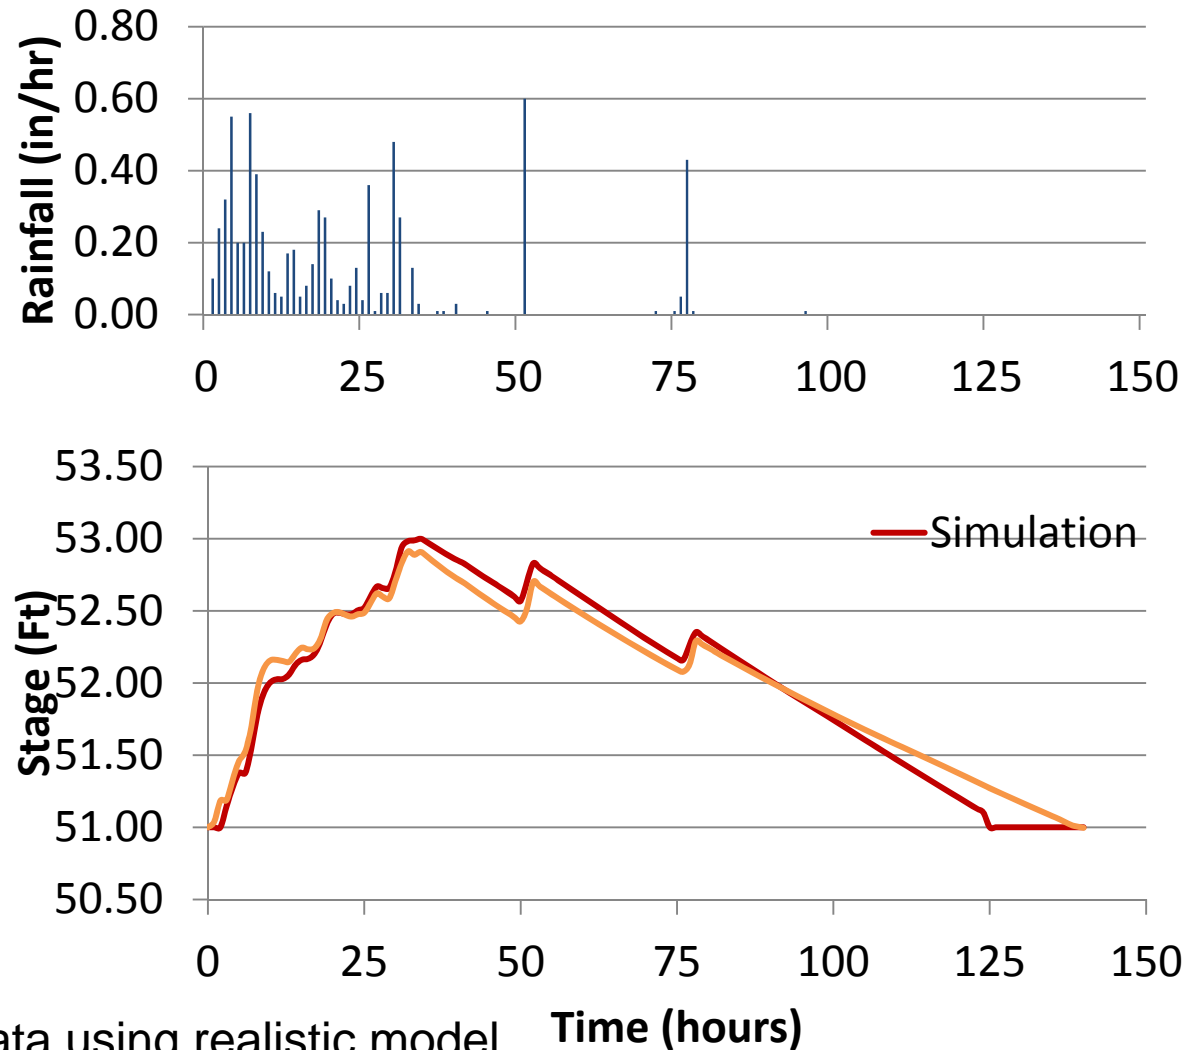
HUNTERS TRACE – Design Model Testing

Simulate August 2008
Tropical Storm Fay event.

The EIA was 1.67 ha
(~20% larger than the DCIA)

Rainfall (inches)	7.30
Infiltration rate (ft/hr)	0.029
Early infiltration (ft/hr)	0.120

- Runoff/water-balance model:
 $R \times EIA - \text{Infil.} = \Delta \text{Storage}$

Good match to field data using realistic model parameters indicates model is suitable for design purposes.

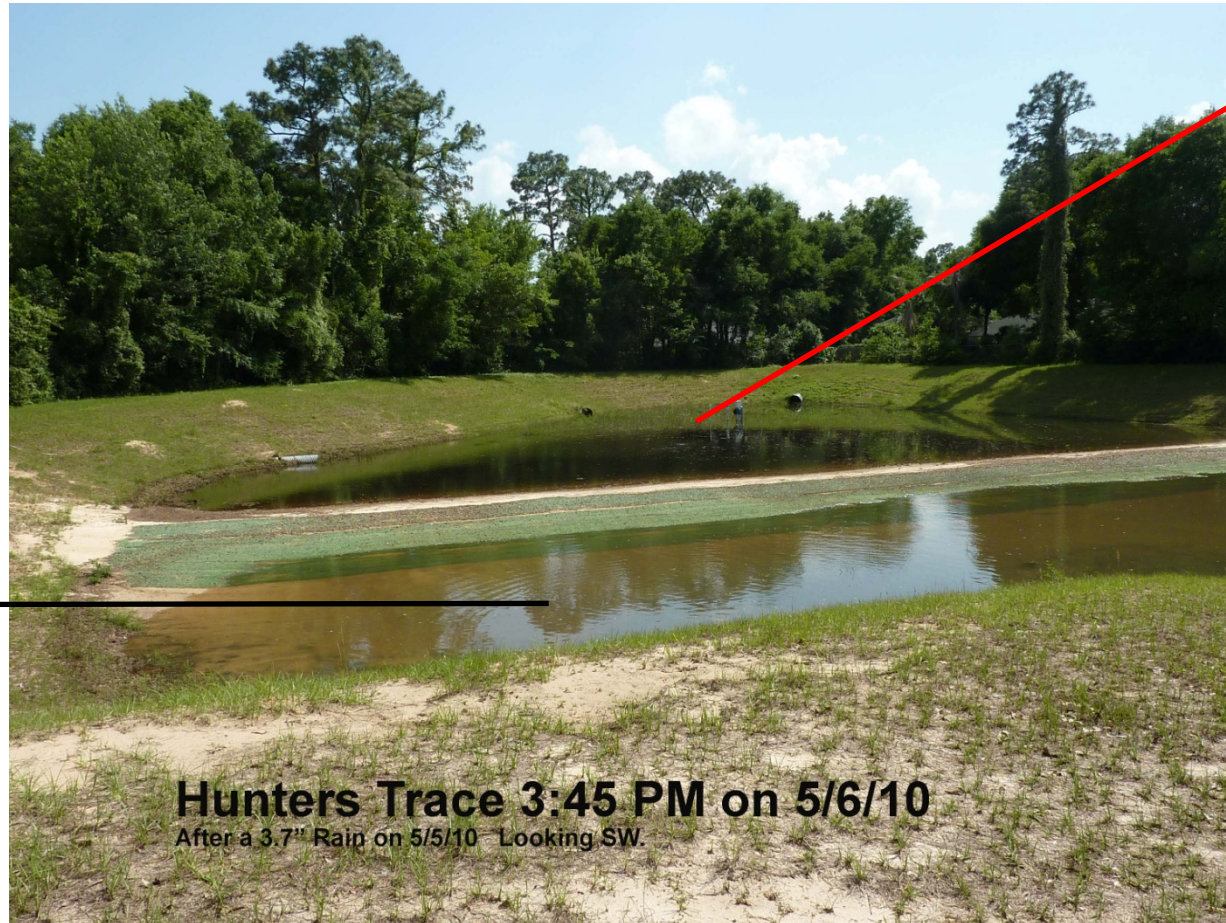
Operating Photo

After placement of erosion control blanket on berm and
3.7 inch storm

Nutrient
or
Pollution
Control
Basin

Flood
Control
Basin

Hunters Trace 3:45 PM on 5/6/10
After a 3.7" Rain on 5/5/10 Looking SW.

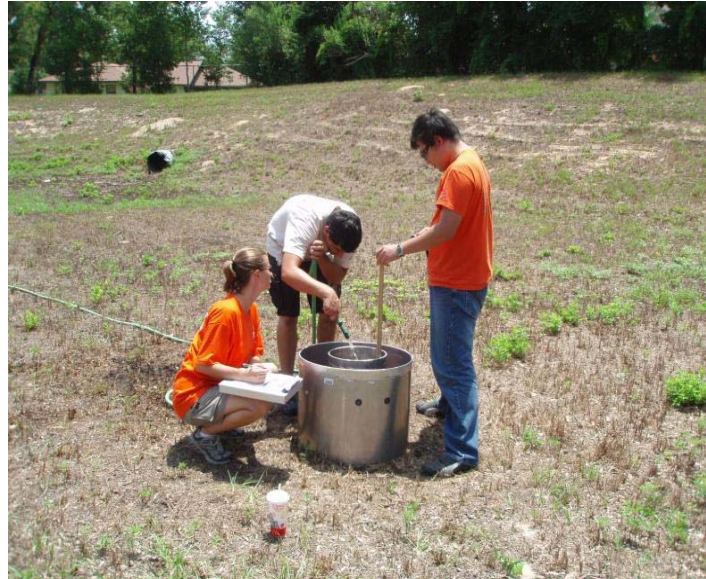
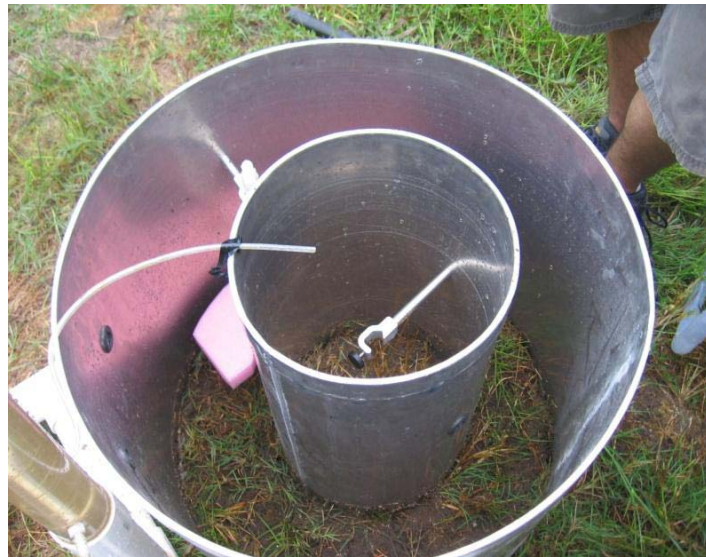
Limiting Infiltration Rates Double Ring and Operational

- SO Double Ring
0.3 ft/hr (7.2 ft/day)
- SO Operational
0.05 ft/day
- HT Double Ring
1.1 ft/hr (26.4 ft/day)
- HT Operational
0.72 ft/day
After BAM
Operational
(0.52 – 0.88 ft/day)
