Final Report FDOT Project BD521-02

Performance Assessment of Portland Cement Pervious Pavement

Report 2 of 4: Construction and Maintenance Assessment of Pervious Concrete Pavements

Stormwater Management Academy
University of Central Florida
Orlando, FL 32816

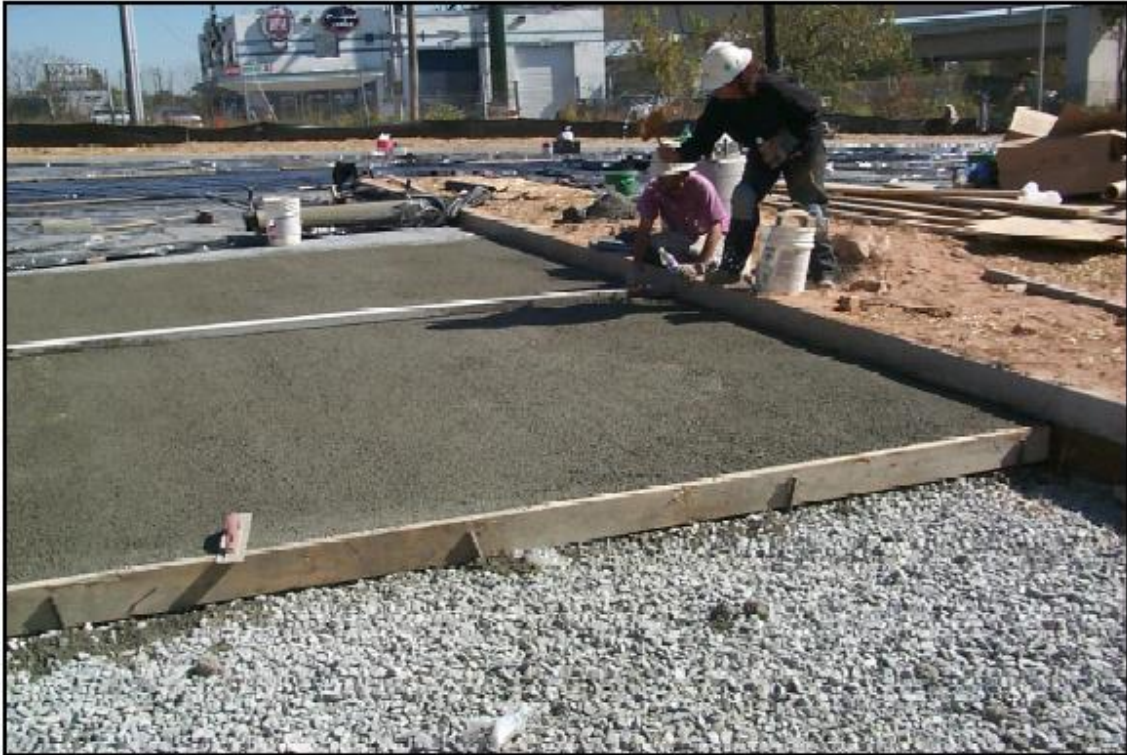
Figure 2: Typical Porous Concrete Installation

Porous concrete systems are typically used in low-traffic areas, such as, parking pads in parking lots, residential street parking lanes, recreational trails, golf cart and pedestrian paths and emergency vehicle and fire access lanes. Heavy vehicle traffic use must be limited to ensure raveling or structural failure does not occur in the porous pavement surface, which may fail under constant exposure to heavy vehicle traffic. The slopes of these installations should be flat or gentle to facilitate infiltration versus runoff and the EPA recommends a four-foot minimum clearance from the bottom of the system to the water table if infiltration is to be relied on to remove the stored water volume (EPA, 1999). Figure 2 shows a typical porous concrete installation.

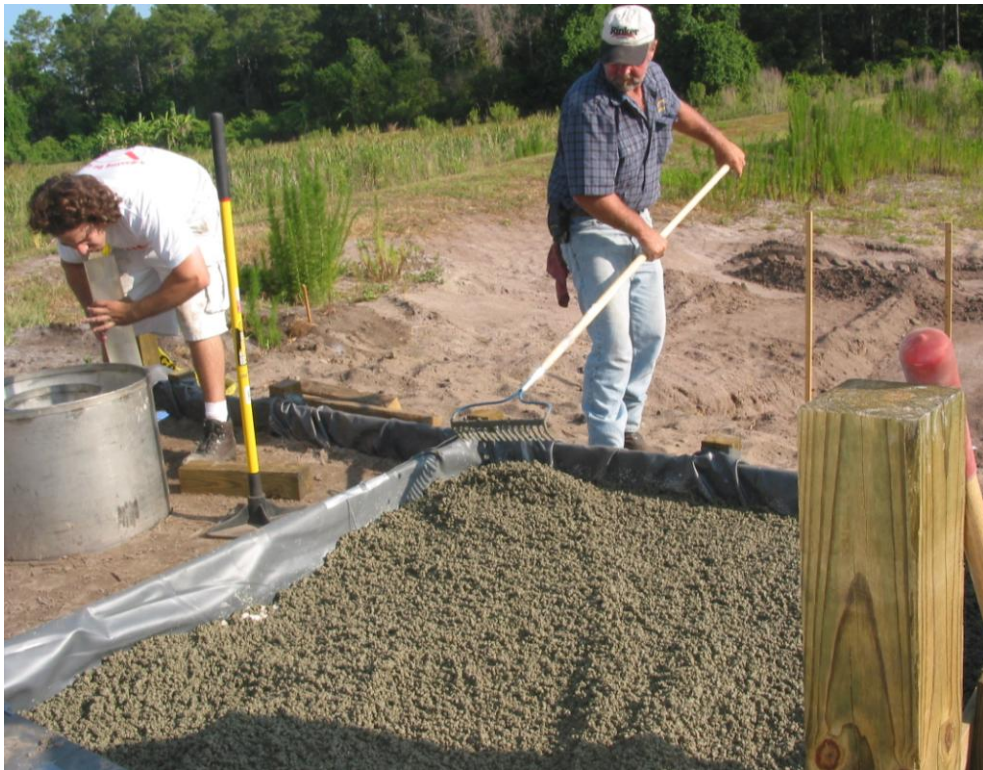
Figure 3: Stormwater Academy Porous Concrete Test Cell Installation

per hour as determined by application of a double-ring infiltrometers test (ASTM D 3385-94). One cell contains a five-inch deep reservoir of $\frac{3}{8}$ to $\frac{1}{2}$ inch coarse aggregate, and both cells have a five- inch thick pervious concrete slab. Depicted in Figure 3 is the installation of the pervious concrete in the test cells as well as a double-ring infiltrometer test being performed on the compacted subsoil.

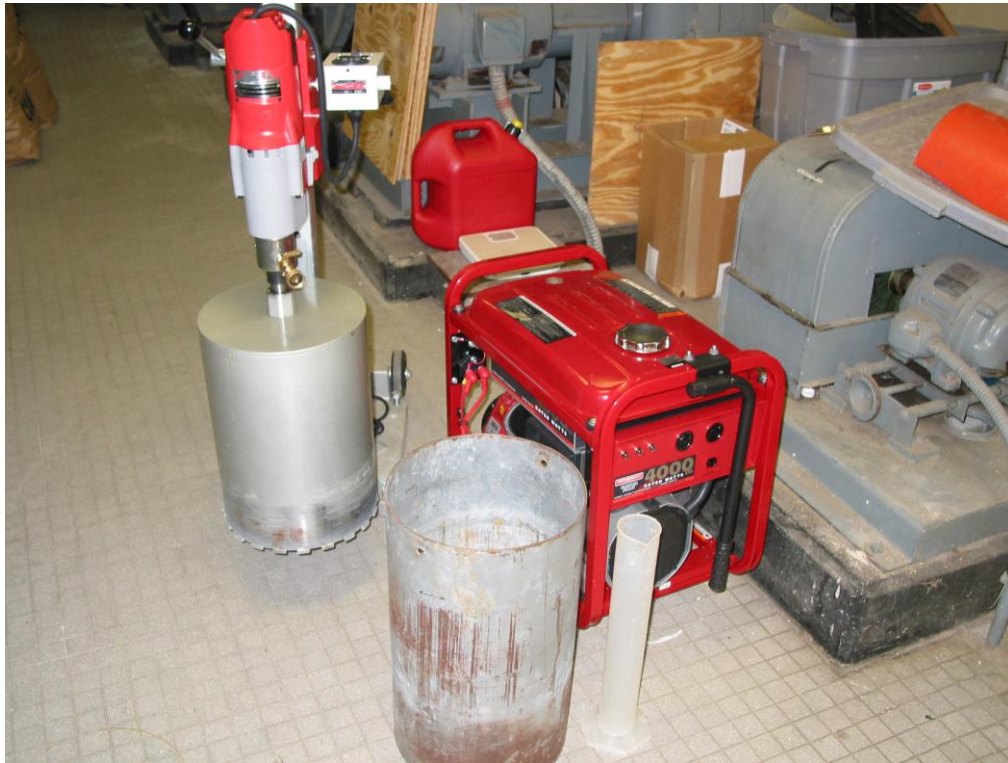
Figure 7: Coring Rig, Core Bit, Single-Ring Infiltrometer, and Generator

1. The pervious concrete surface is cored in three evenly spaced locations utilizing a 12 inch outside diameter, diamond tipped concrete core bit. The drilling process takes between 10 and 30 minutes per concrete core depending on the type of aggregate used in the concrete mix and depth of the concrete slab. The coring rig and the core bit are shown in Figure 7.

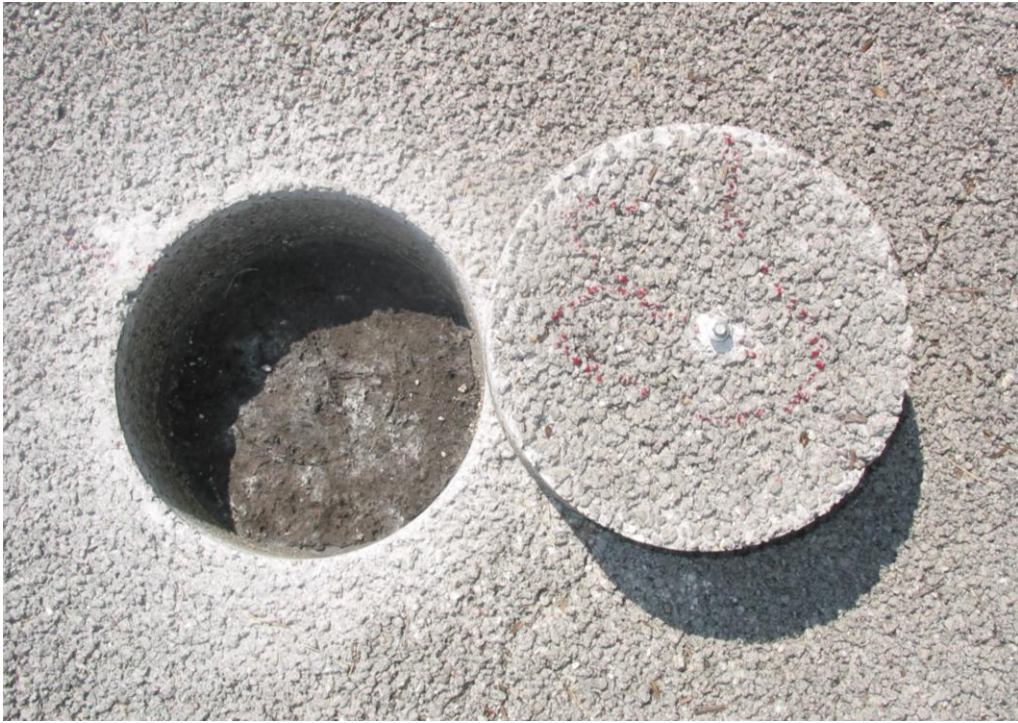
Figure 8: Pervious Concrete Pavement Core

The core samples are left in place after drilling for in-situ infiltration testing. When necessary, the cores were extracted and grinded along the sides to remove irregularities formed during the coring process to allow the single-ring infiltrometer to fit around the core. A four-inch angle grinder with a masonry disk was utilized for this task. Figure 8 shows the 12 inch core placed next to the location it was removed from in the pavement. It is clear that the pavement system at this site does not have a drainage layer of gravel. This configuration is typical for pavements on soils with high permeability values.

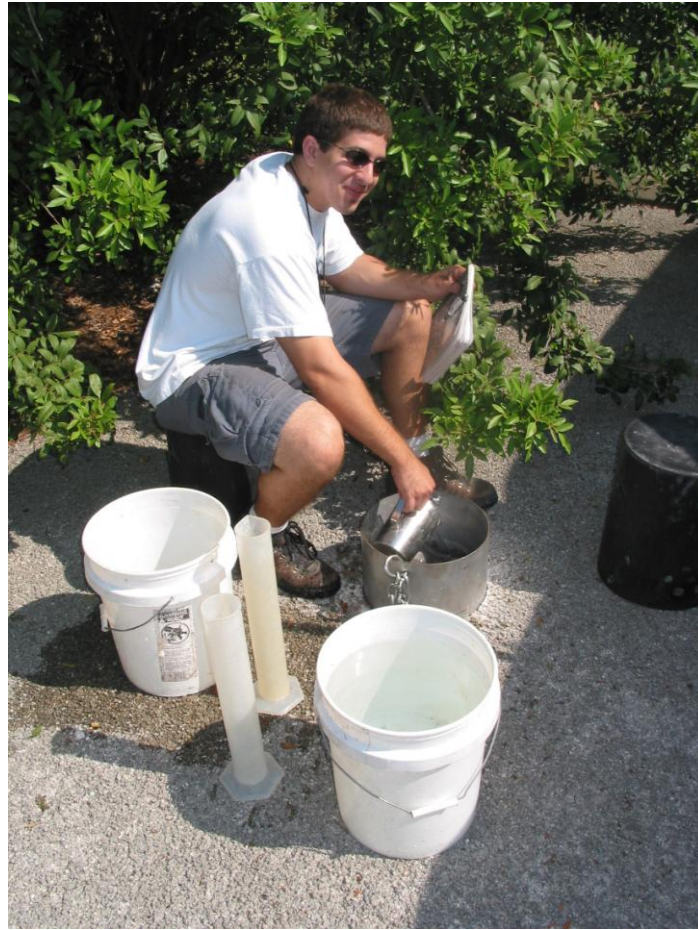
Figure 9: Pervious Concrete Pavement Core Test

2. Once the single-ring infiltrometer can pass into the cut made by the coring rig, the infiltrometer is embedded into the subsoil by applying a downward force. The infiltrometer is typically installed using a hand-tamper making sure to mark the infiltrometer before embedment to ensure the infiltrometer is installed to the proper depth.
3. After the single-ring infiltrometer is embedded to the proper depth, a bead of plumber's putty is placed around the inside circumference of the infiltrometer to prevent side-wall leakage.
4. Infiltration rates of the three cored locations are measured using the embedded Single-ring Infiltrometer Test as discussed in the previous section. Figure 9 shows a test in progress with the infiltrometer in the embedded state.

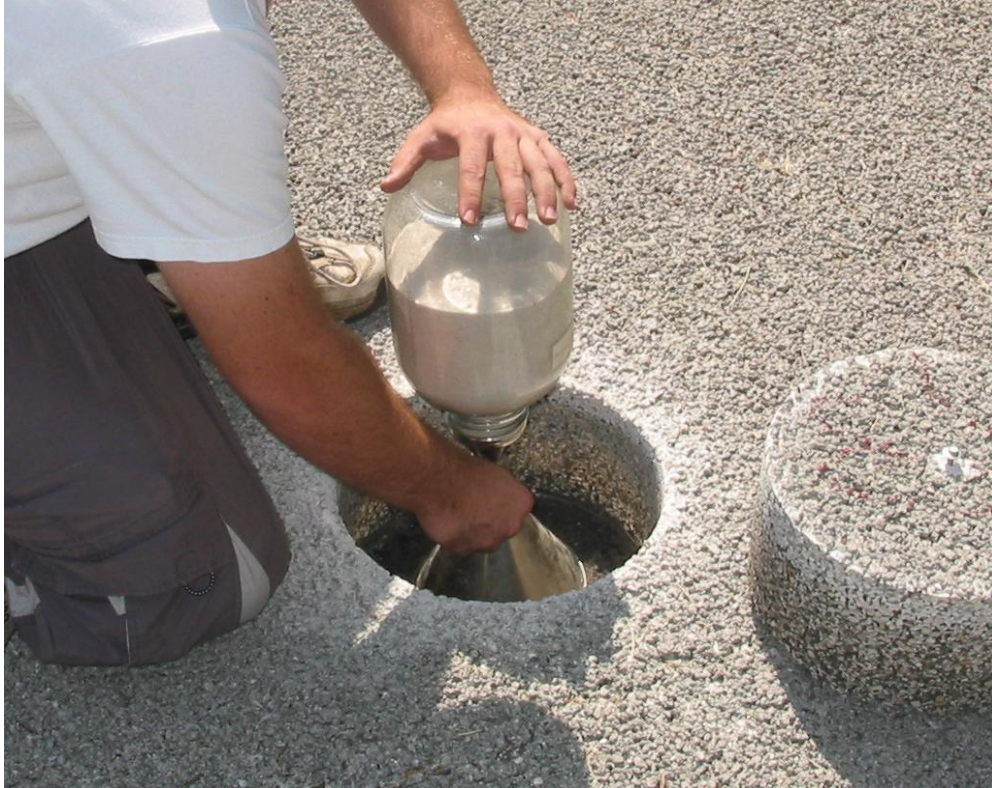
Figure 10: Performing Sand Cone Test

7. The field unit weight of the subsoil is then determined using the Sand Cone Method as outlined in ASTM D 1556 “Standard Test Method for Density and Unit Weight of Soil in Place by the Sand-Cone Method”. Figure 10 shows a sand cone test in progress.

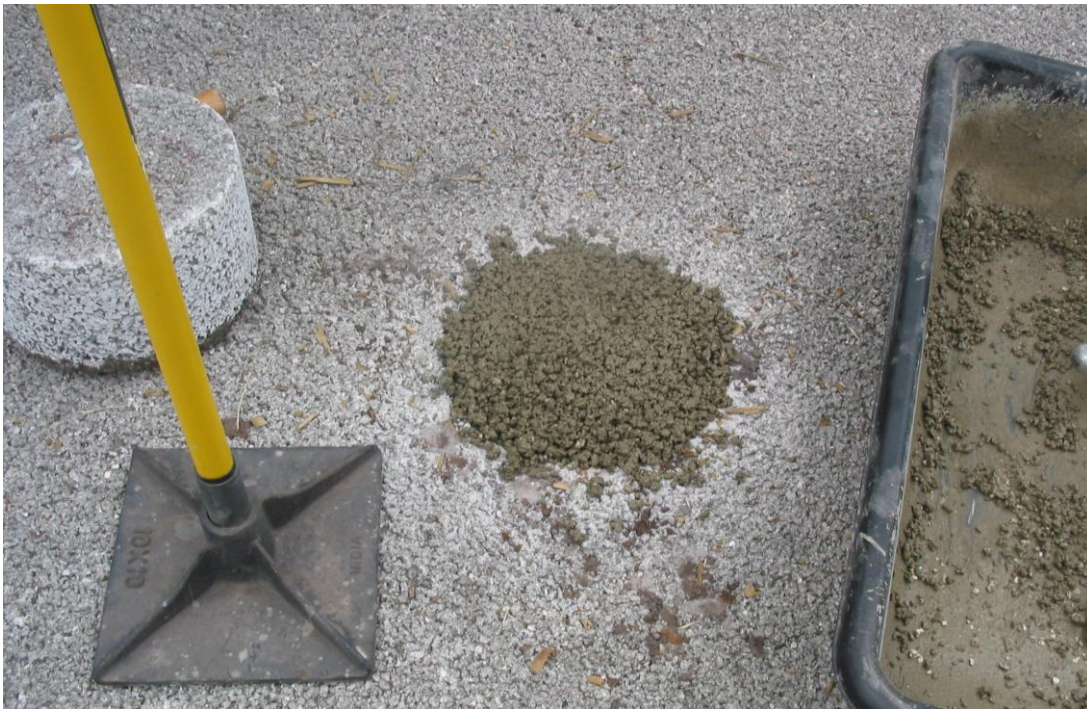
Figure 11: Repair of Concrete Core Area

9. Water table depths are recorded for use in modeling studies planned for the pervious concrete system.
10. The subsoil shall be replaced and the pervious concrete is repaired using the original specifications at the locations where it was cored. An example of this patching is depicted in Figure 11.

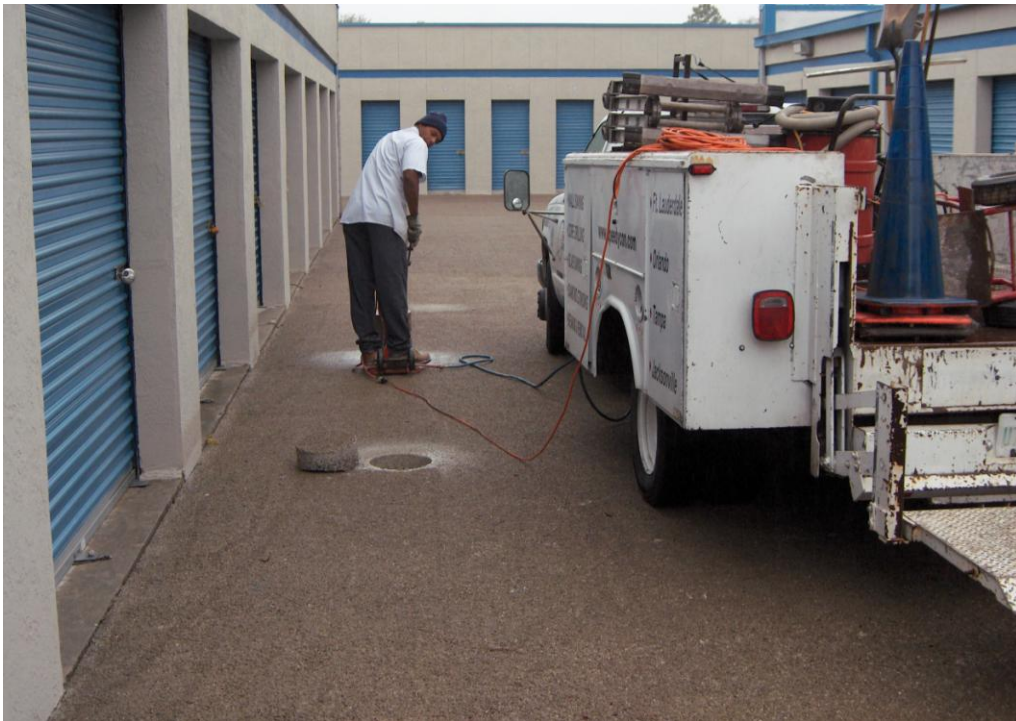
Figure 16: Sun Ray Store-Away Pervious Pavement at Core Locations 1, 2 & 3

infiltration rates measured in the laboratory that ranged from a high of 627 to a low of 3 in/hr. Instances where the system infiltration rates are higher than the individual core infiltration rates measured in the lab is due to infiltration along the sidewall of the cores that occurred in the field but was restricted in the lab producing false high infiltration rates in the field. The cores performed in the area of cores 1, 2 and 3 exhibited higher infiltration rates than other areas. This result was anticipated as the pervious concrete surface in that area was after visual determination in better condition; this area is shown in Figure 16.

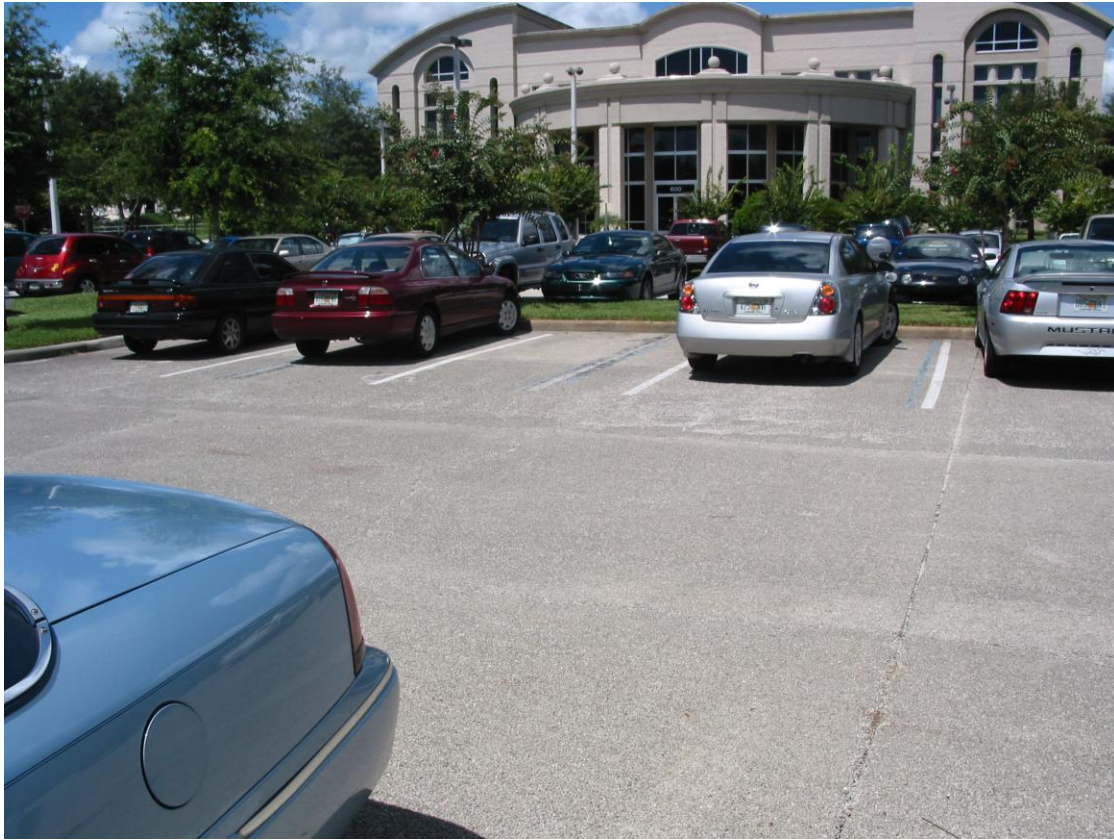
Figure 18: Strang Communication Office Parking Lot

This pervious parking lot exhibited minimal damage to the surface, although, significant raveling has taken place in one location on the site. Raveling is the deterioration of the concrete due to repeated loads over time on an area. The nine spaces located in the northwest area of the pervious concrete are raveling at the entrance to each stall. Also, a small amount of raveling at the entrance to the parking row on the west was also noted. Algae and leaf debris staining are also present over a majority of the pervious concrete parking lot. Figure 17 shows the location of the raveling and algae in this parking area. Depicted in Figure 18 is a picture of this site.

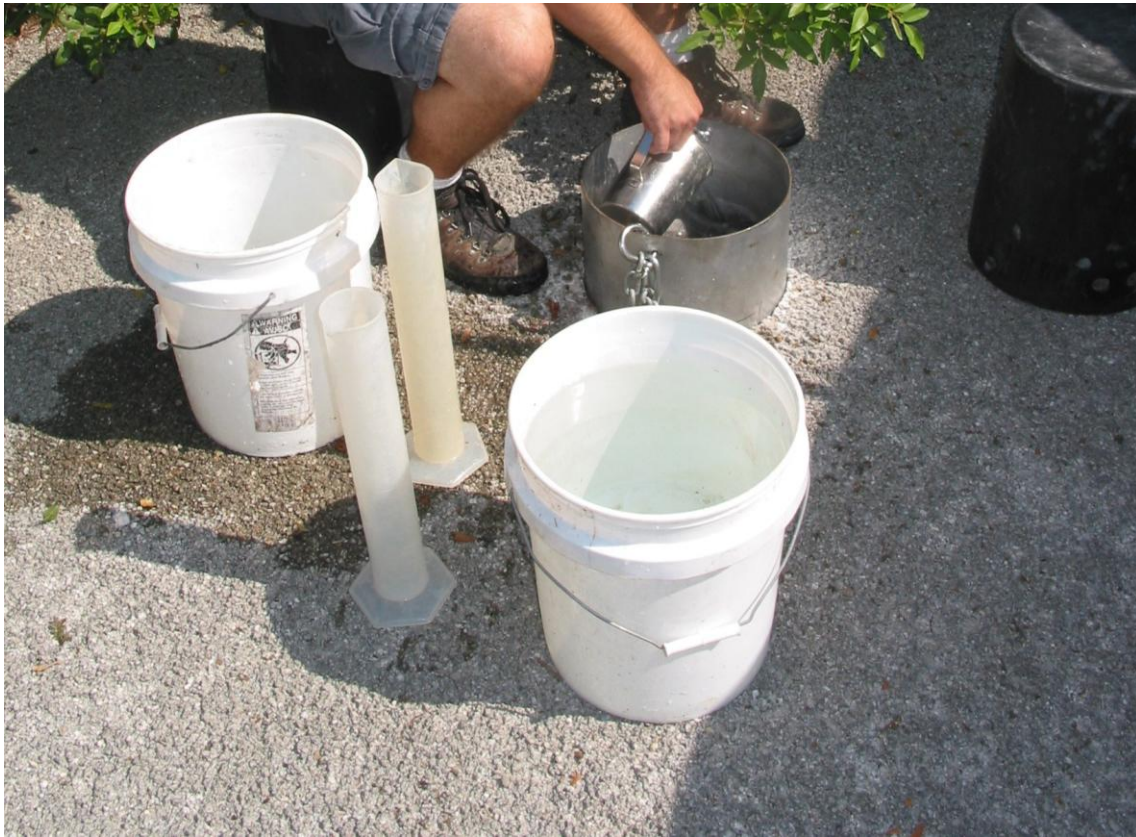
Figure 20: Murphy Veterinarian Clinic Core Test

The subsoil characteristic to the pervious concrete parking lot at the Murphy Veterinarian Clinic exhibited infiltration rates typical of type A hydrologic soils. Infiltration rates of the subsoil ranged from 15.78 to 27.21 in/hr. in the field and 3.41 to 7.91 in/hr. in the laboratory permeability tests. The difference in infiltration rate is believed to be due to the higher level of compaction of the laboratory soil samples. Field system infiltration rates were not measured due to the lack of access to a power source at the field site, which limited the ability to grind the sides of the pervious concrete cores to allow the single-ring infiltrometer to fit around the core. Core infiltration rates exhibited infiltration rates measured in the laboratory that ranged from 2.3 to 24 in/hr. This result indicates that the pervious concrete surface is acting as the limiting factor at this pervious concrete installation. Figure 20 depicts a subsoil infiltration test being performed at the field site.

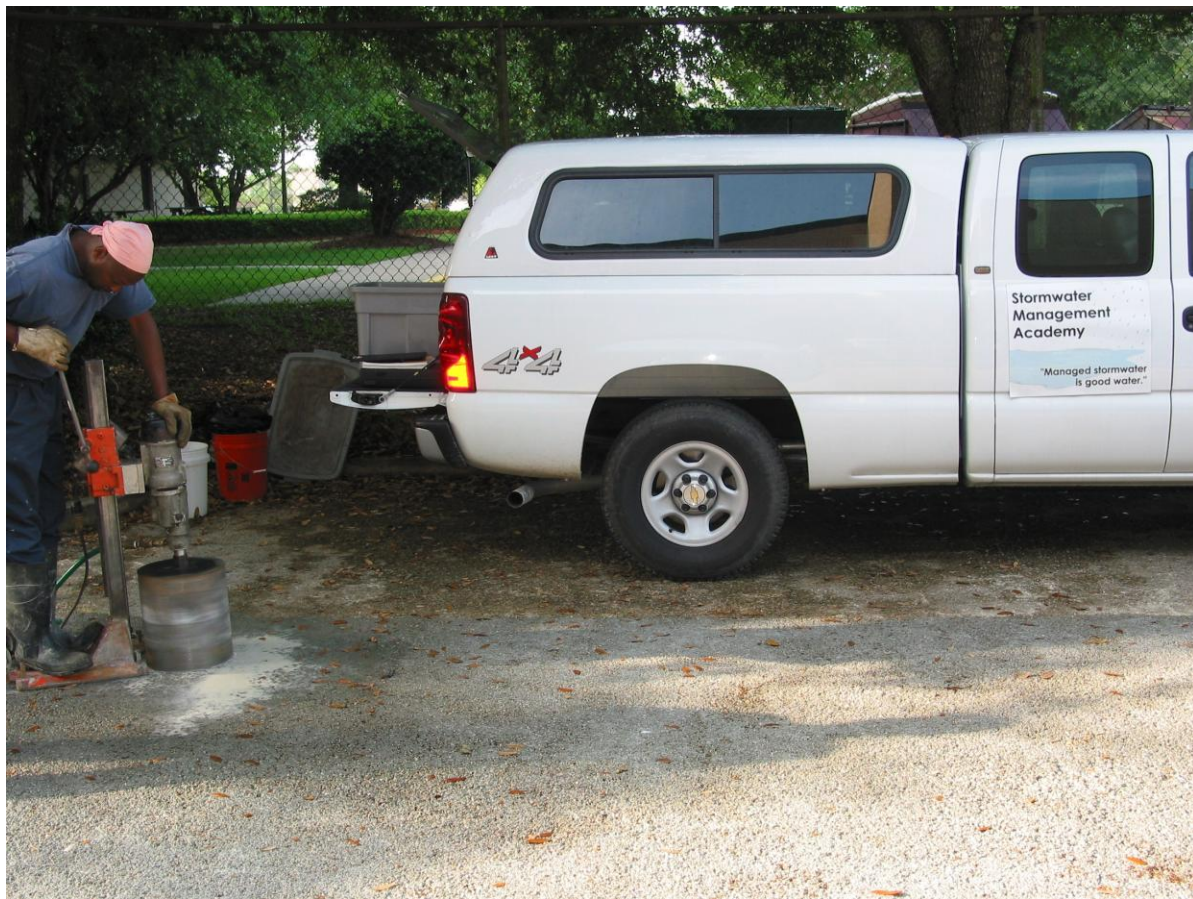
Figure 22: FDEP Parking Lot Core Test

ranged from 0 to 5.2 in/hr. The cores performed in the area of cores 4, 5 and 6 exhibited higher infiltration rates than other areas. This result was anticipated as the condition of the pervious concrete surface in the other areas was compromised due to poor construction practices. Higher than typical unit weights are also indicative of poor construction practices. Low infiltration rates of the subsoil in the areas of Cores 4 through 6 was due to a layer of poorly draining, orange clay encountered directly beneath the pervious concrete. Figure 22 depicts the coring operation performed at this site.

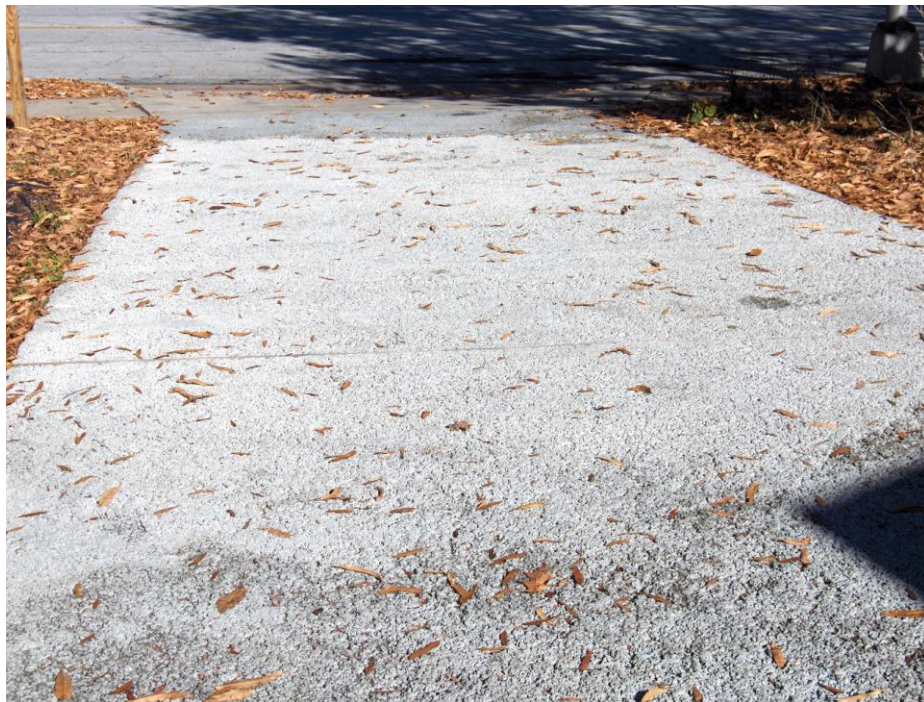
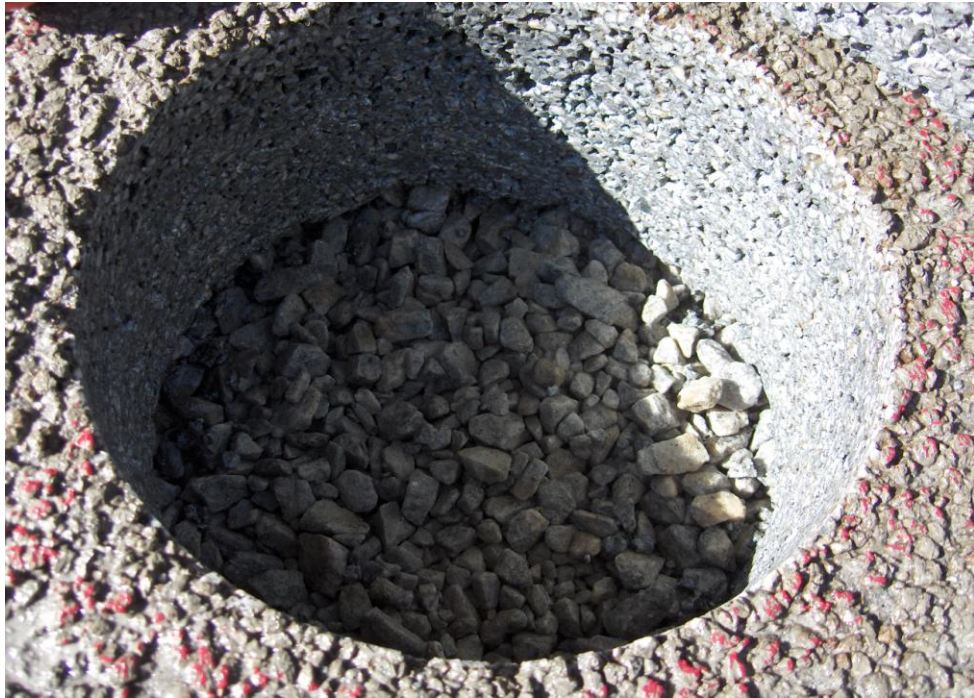
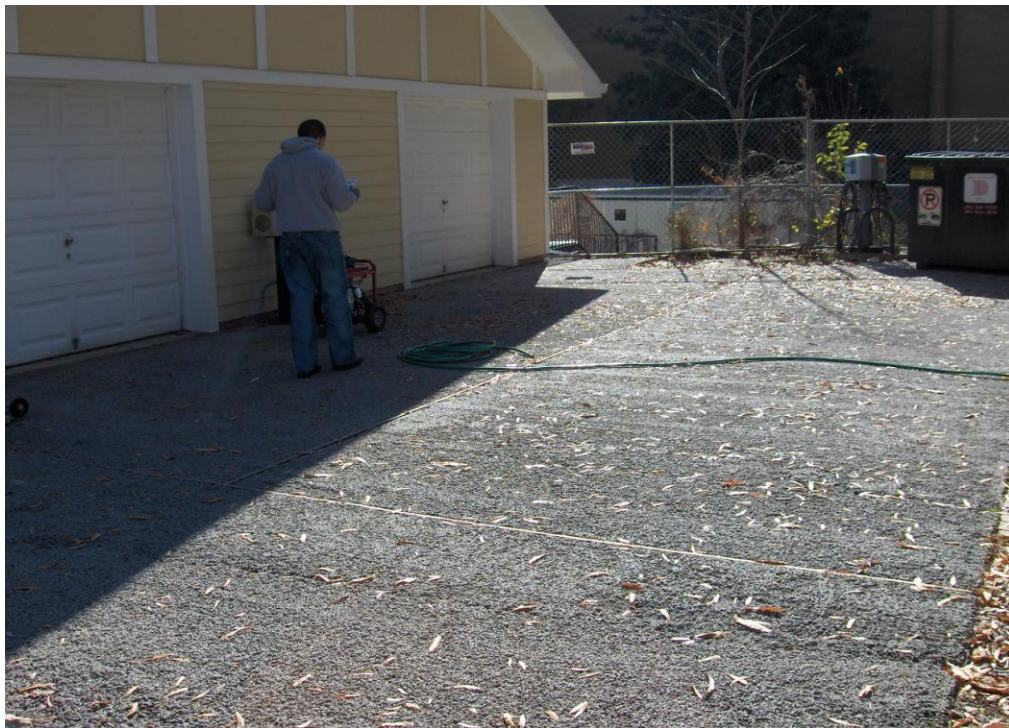
188 in/hr. This wide range of infiltration rates can be contributed to varying surficial pore sizes and unit weights in pervious concrete due to poor construction techniques. Field system infiltration rates were not measured due to the presence of a gravel reservoir, which the single-ring infiltrometer is unable to penetrate. These results indicate that the subsoil is acting as the limiting factor at this pervious concrete installation, however a gravel reservoir has added storage to the site to allow a longer recharge time. Laboratory tests indicate the gravel reservoir has a porosity of approximately 0.32 or a storage capacity of approximately 2 inches of water. Photographs depicting the condition of the pervious concrete in this area are shown in Figures 26, 27 and 28.

Figure 26: Southface Institute Parking Lot

Figure 27: Southface Institute Gravel Subbase

Figure 28: Southface Institute Parking Lot

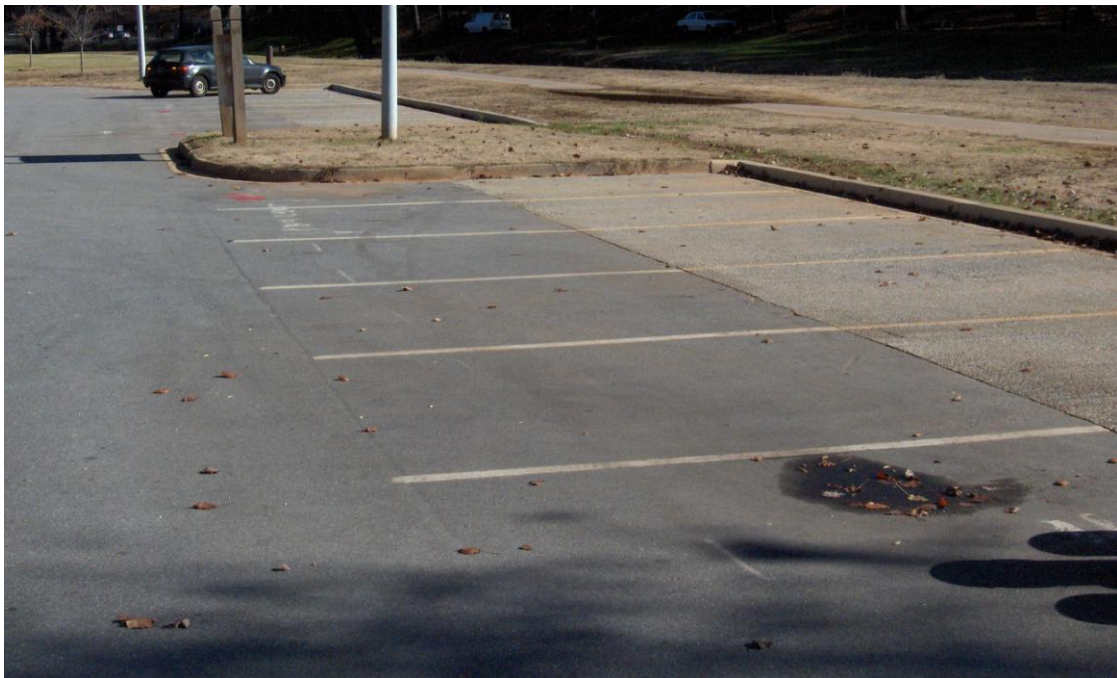
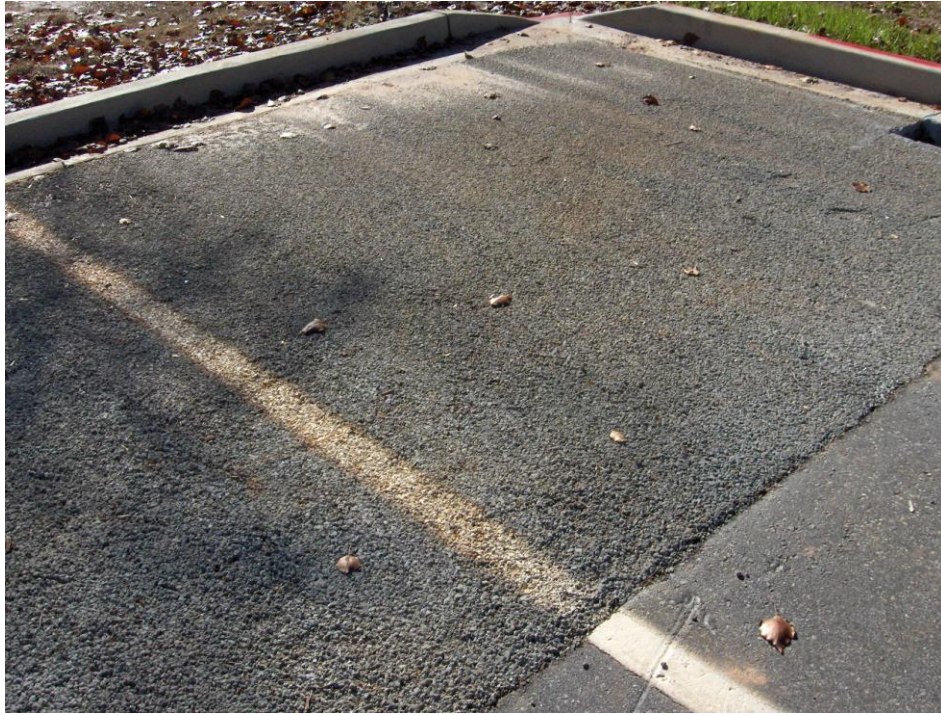
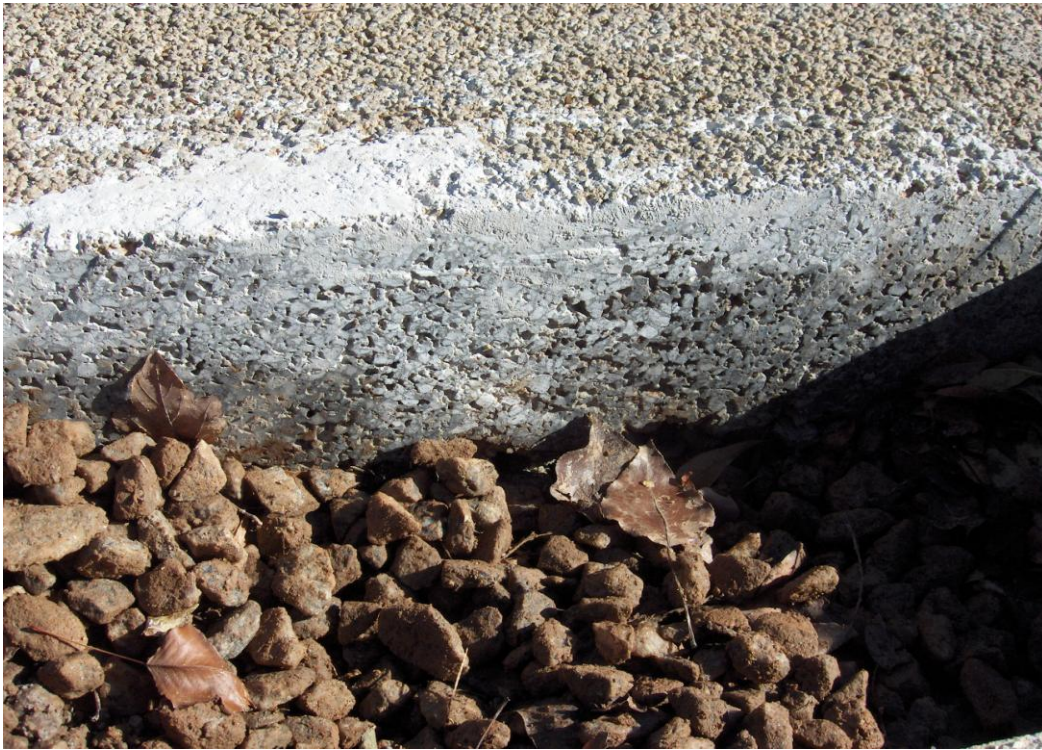
zero that was measured was due to a lack of voids present in the concrete due to poor construction techniques as verified by the comparatively high unit weight of the core. Field system infiltration rates were not measured due to the presence of a gravel reservoir, which the single-ring infiltrometer is unable to penetrate. These results indicate that the subsoil is acting as the limiting factor at this pervious concrete installation, however, a gravel reservoir has added storage to the site to allow a longer recharge time. Laboratory tests indicate the gravel reservoir has a porosity of approximately 0.32 or a storage capacity of approximately 2 inches of water. Photographs depicting the condition of the pervious concrete in this area are shown in Figures 30, 31 and 32.

Figure 30: Cleveland Park Parking Lot

Figure 31: Cleveland Park Parking Lot Pavement

Figure 32: Cleveland Park Parking Lot Reservoir

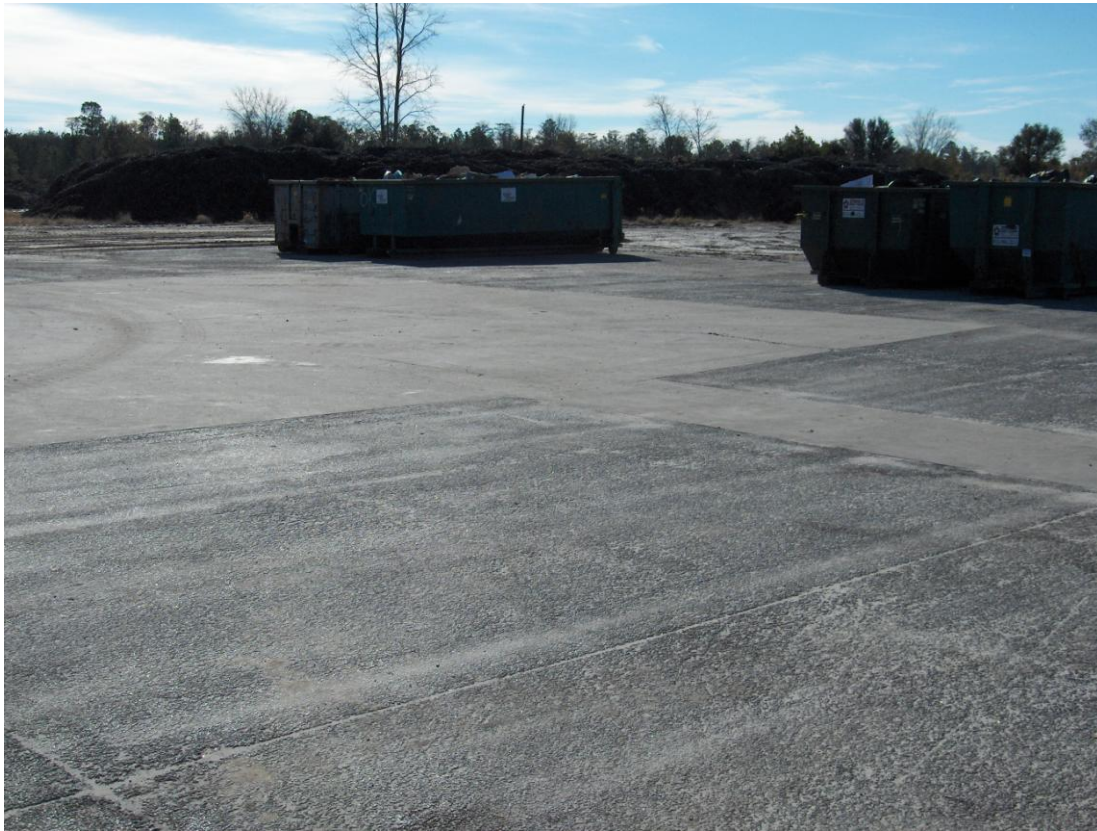
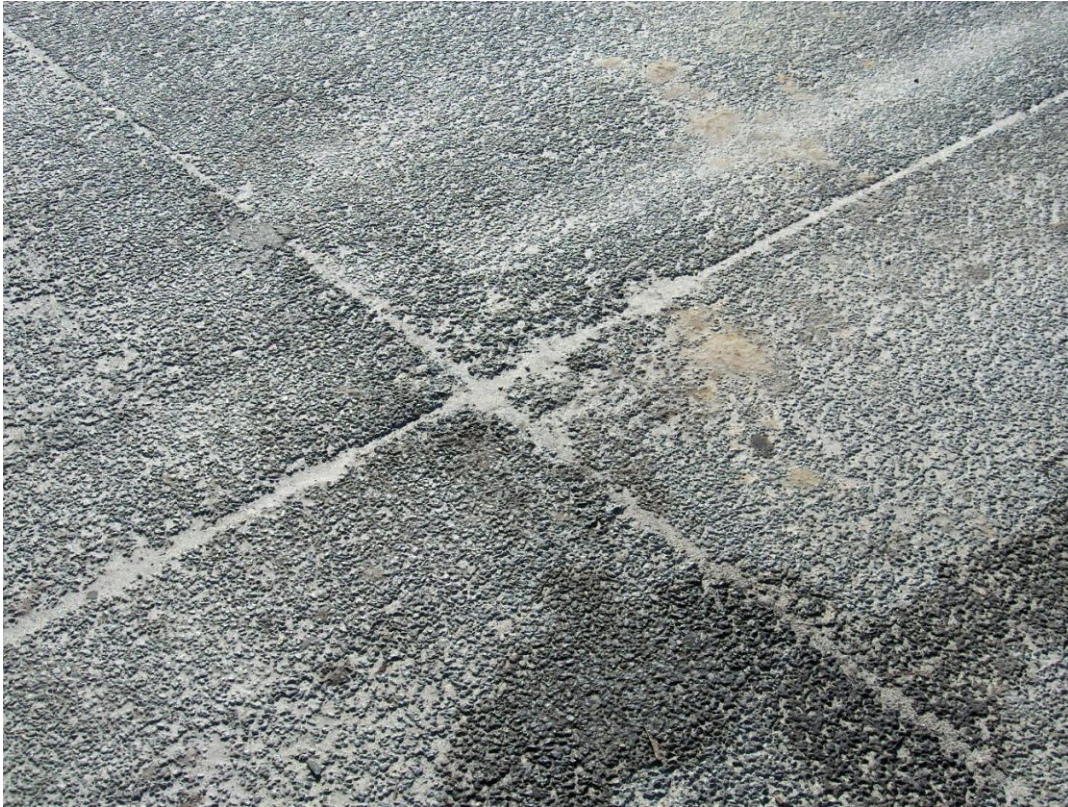
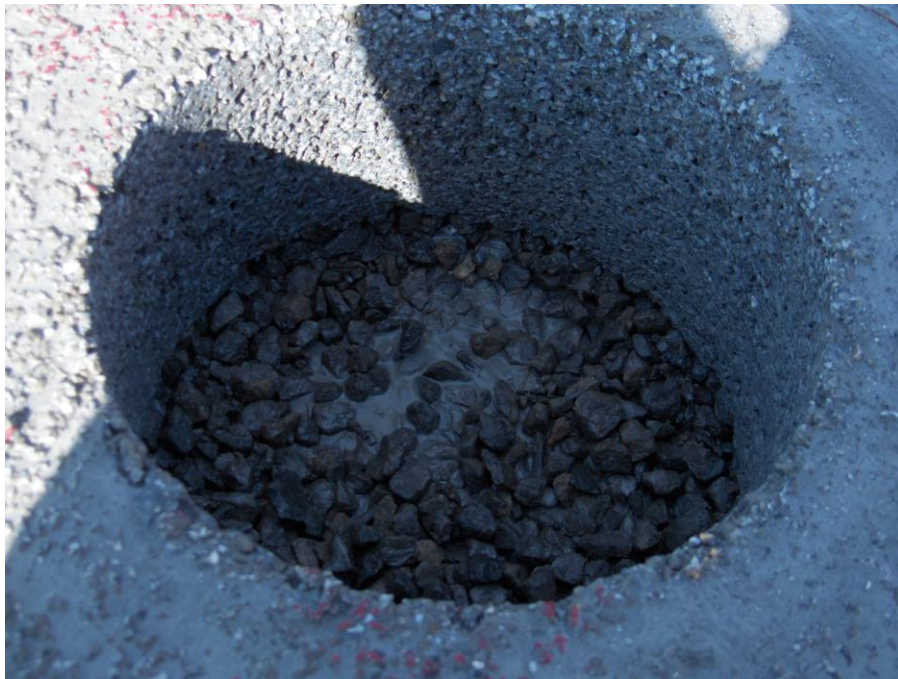
be attributed to varying surficial pore sizes in the pervious concrete due to poor construction techniques. Field system infiltration rates were not measured due to the presence of a gravel reservoir, which the single-ring infiltrometer is unable to penetrate. These results indicate that the subsoil is acting as the limiting factor at this pervious concrete installation, however, a gravel reservoir has added storage to the site to allow a longer recharge time. Laboratory tests indicate the gravel reservoir has a porosity of approximately 0.32 or a storage capacity of approximately 2 inches of water. Photographs depicting the condition of the pervious concrete in this area are shown in Figures 34, 35 and 36.

Figure 34: Effingham County Landfill

Figure 35: Effingham County Landfill Pervious Pavement

Figure 36: Effingham County Landfill Reservoir

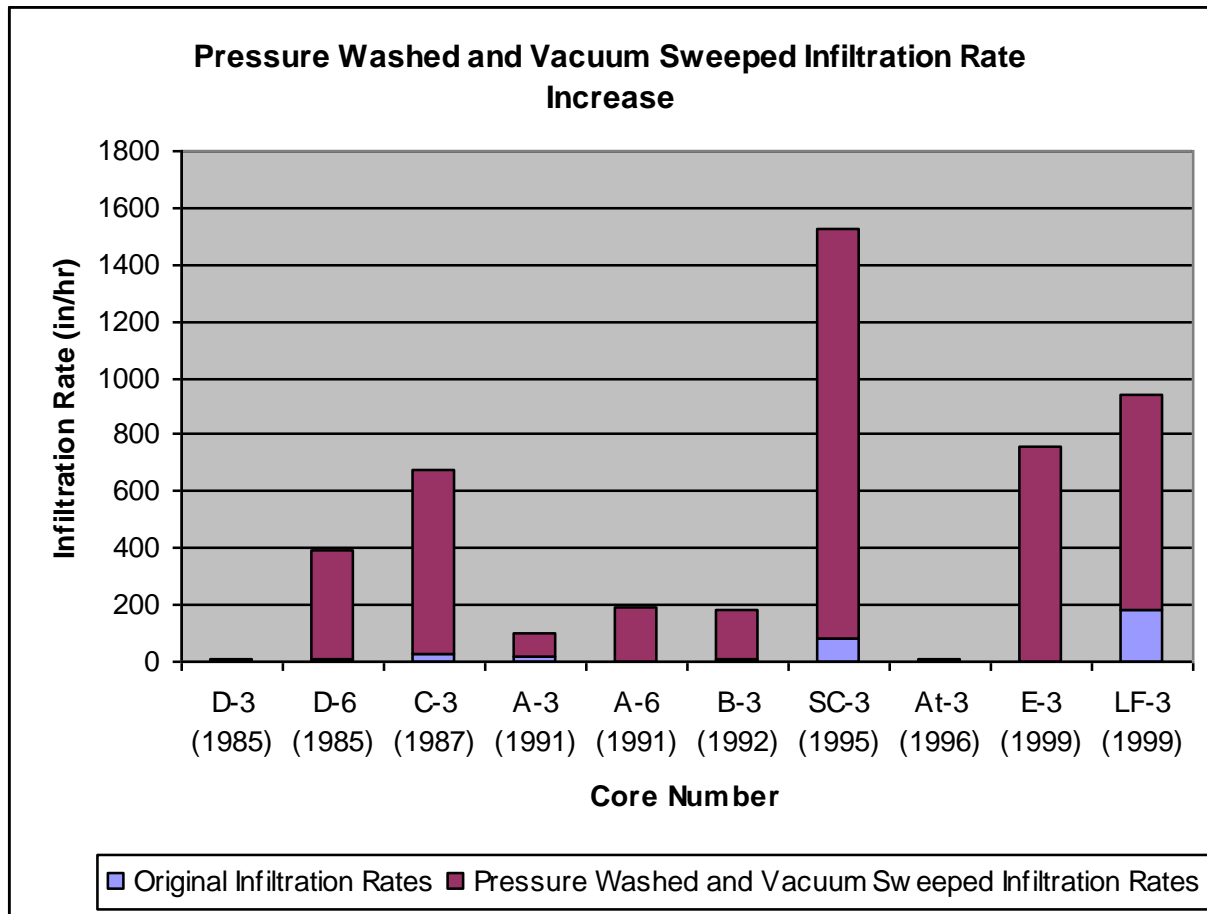
Figure 37: Comparison of Original and Pressure Washed and Vacuum Swept Infiltration Rates

LF-1	31	343	11	1999	Pressure Washed
LF-2	11	35	3		Vacuum Swept
LF-3	187	758	4		Vacuum & Pressure

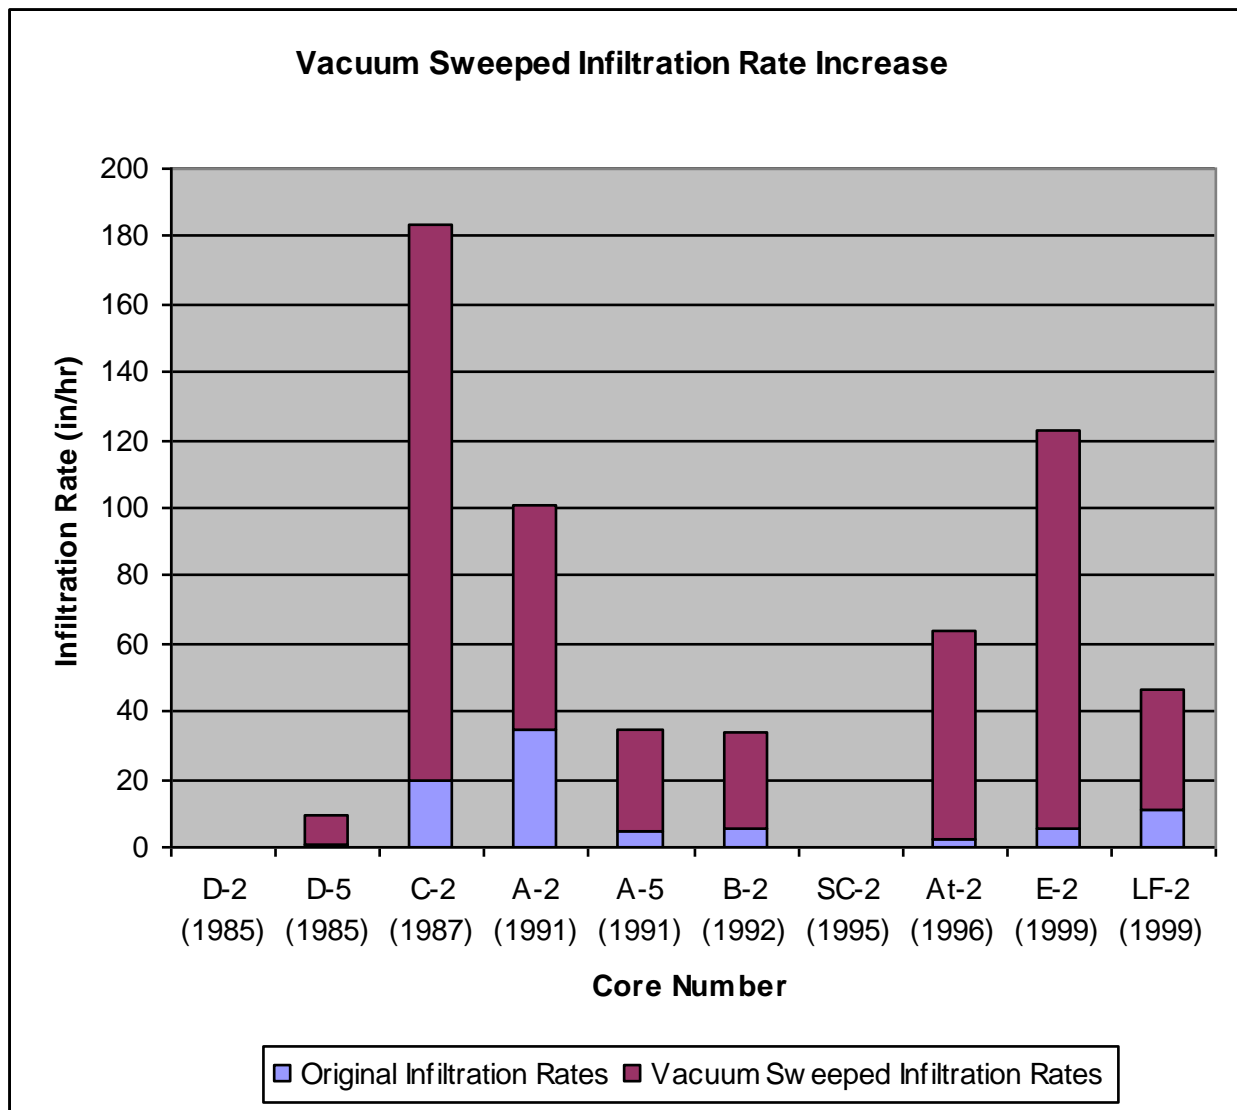
Figure 38: Comparison of original and Vacuum Swept Infiltration Rates

The pervious pavement at sites D2 and SC2 were not installed properly and exhibited the density and zero infiltration characteristics common to regular concrete.

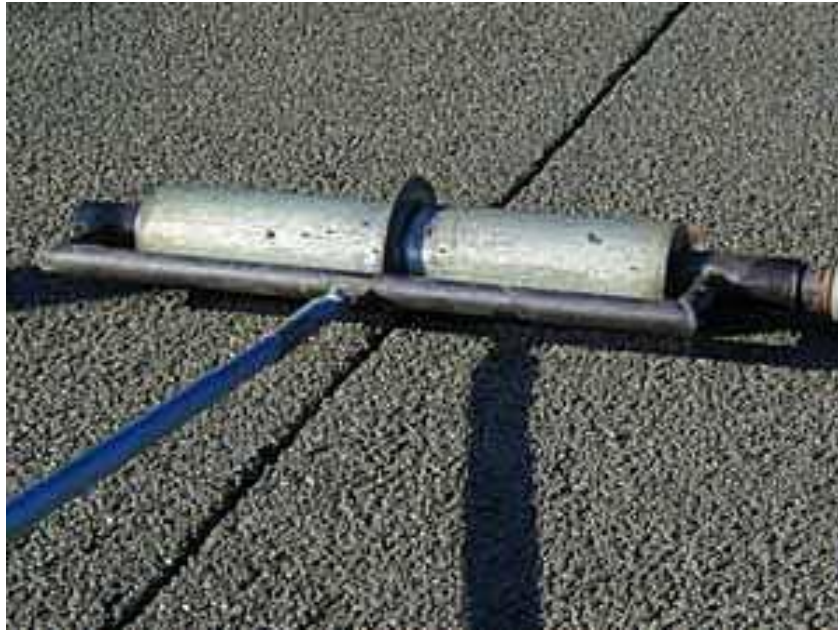
Figure 43: Roller Used to Create Joints in Pervious Concrete
